STUDY REPORT

No. 184 (2007)

An Inspection of Solar Water Heater Installations

C D Kane, A R Pollard and J Zhao

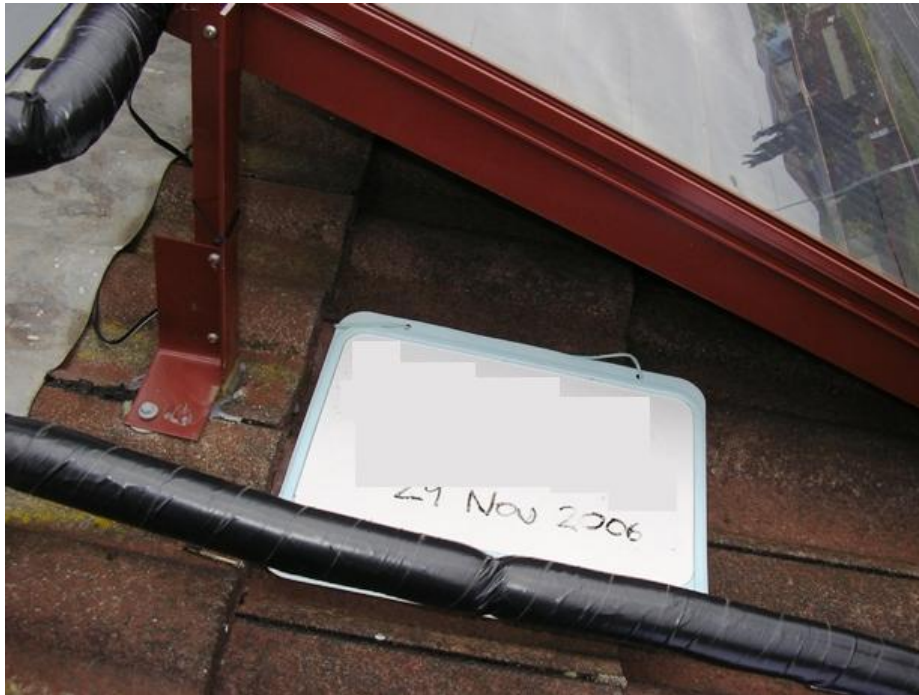
washed by the rain. As explained above, the accumulation of salt and dirt can cause a highly corrosive electrolyte to form on the roof surface, breaking down any protective corrosion products and leading to rapid degradation. The solution here is to regularly wash the area with fresh water. Similar microclimatic conditions can occur inside a flat plate collector if open to the elements. Figure 3 shows a situation where water is trapped inside a collector – whilst no apparent damage had been done at the time of the inspection, the trapped moisture and high temperatures will cause accelerated corrosion attack compared with a hot, dry environment.

Figure 2. Unwashed area under collector can accelerate corrosion of roofing.

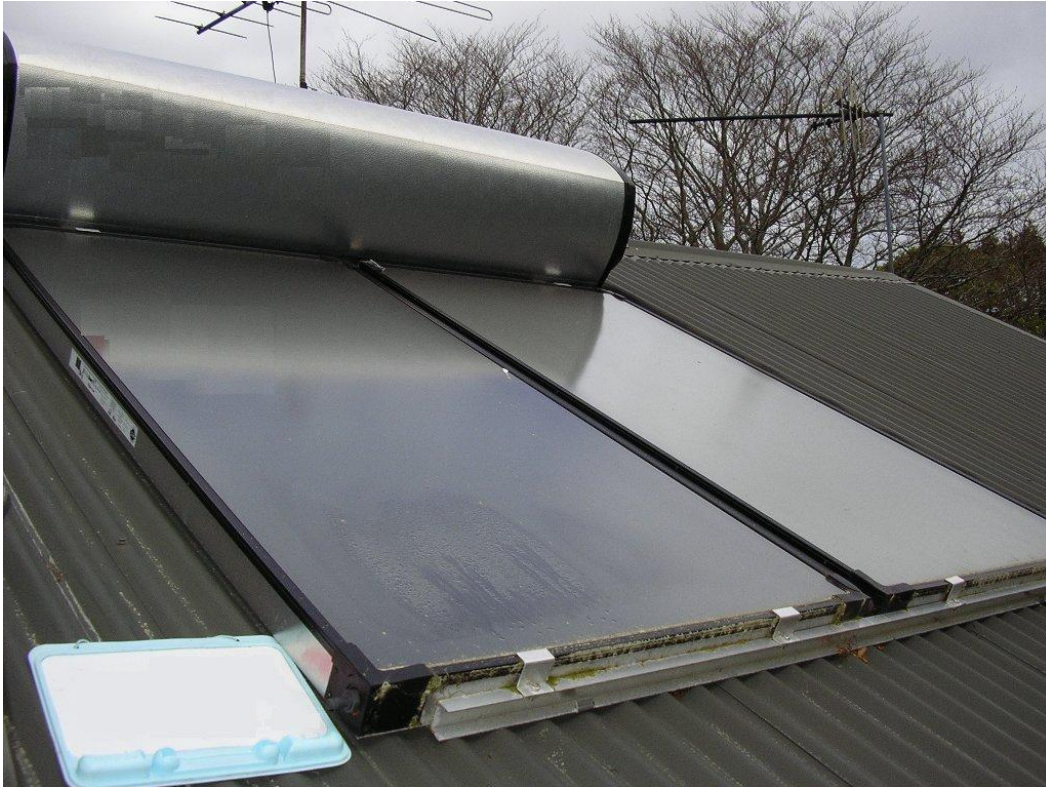
Figure 3. Water trapped inside collector.

Condensation in collectors was noticed on two installations, as shown above in Figure 3 and Figure 47. The collector array is not clearly visible due to the condensation. Figure 48 below gives a close-up shot of the collector surface from Figure 3. The collector array can be seen indistinctly through the glass. No discolouration is visible on the collector.

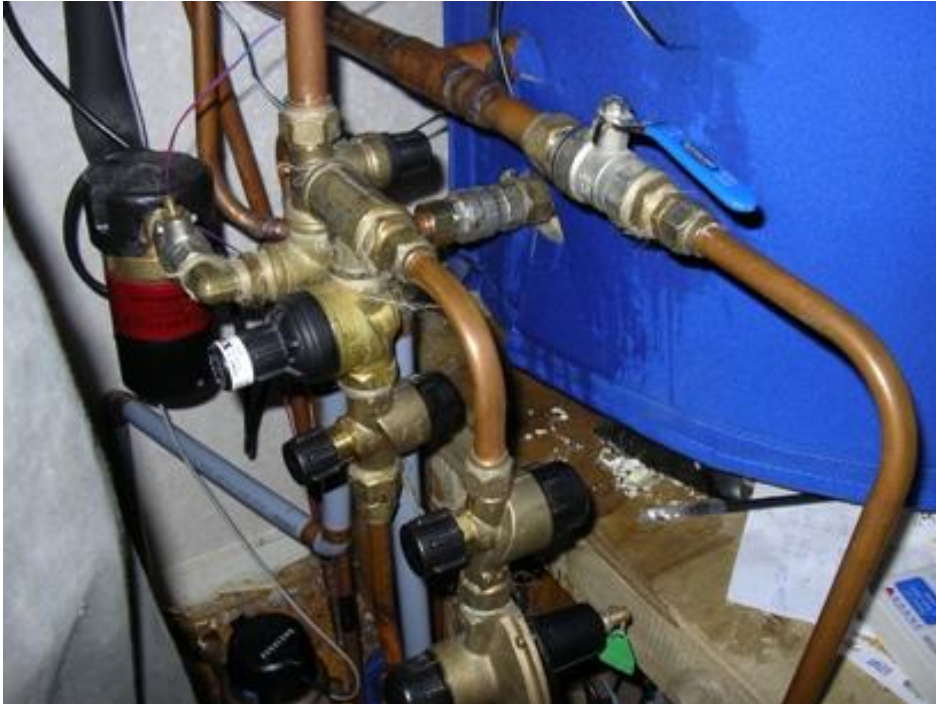
Figure 4. Complicated valve arrangement – the cylinder is within the blue cover to the right.

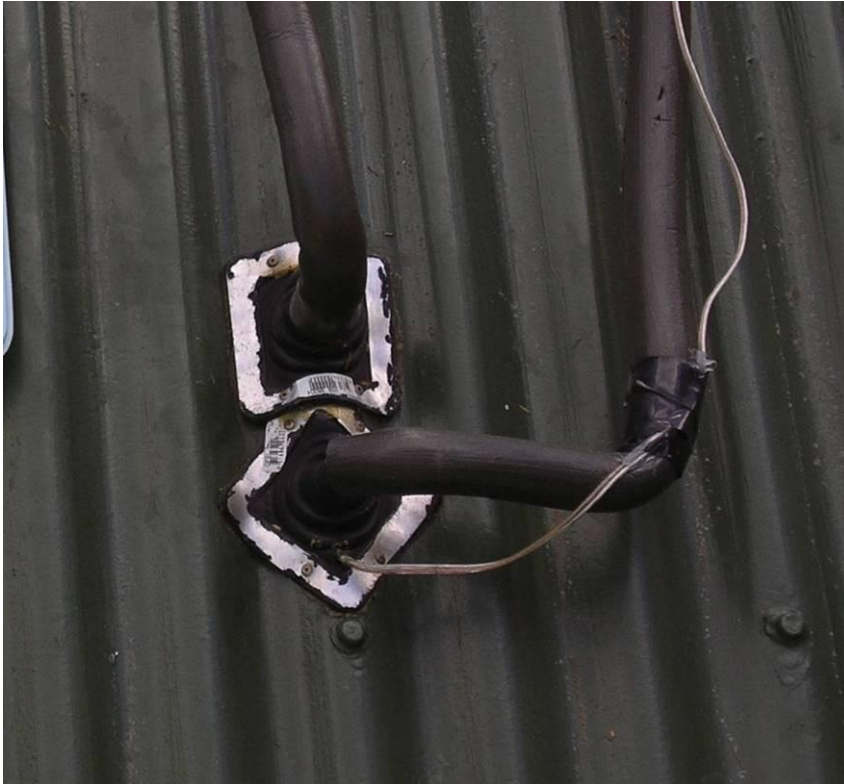
Figure 5. The lagging has been painted to match the roof – no UV damage.

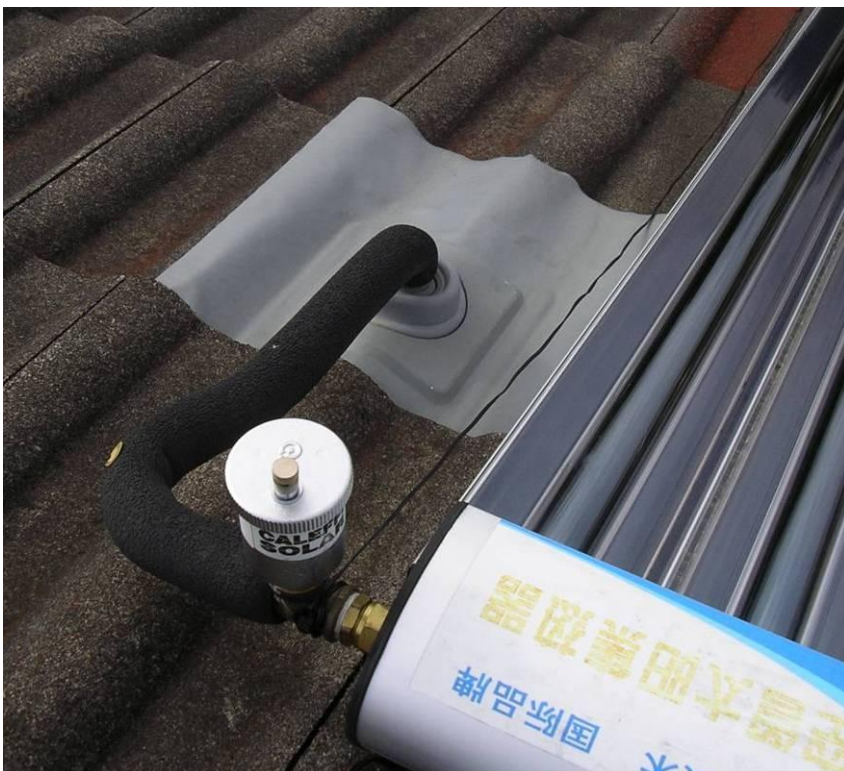
Figure 6. The lagging follows the bends nicely, but has begun degrading.

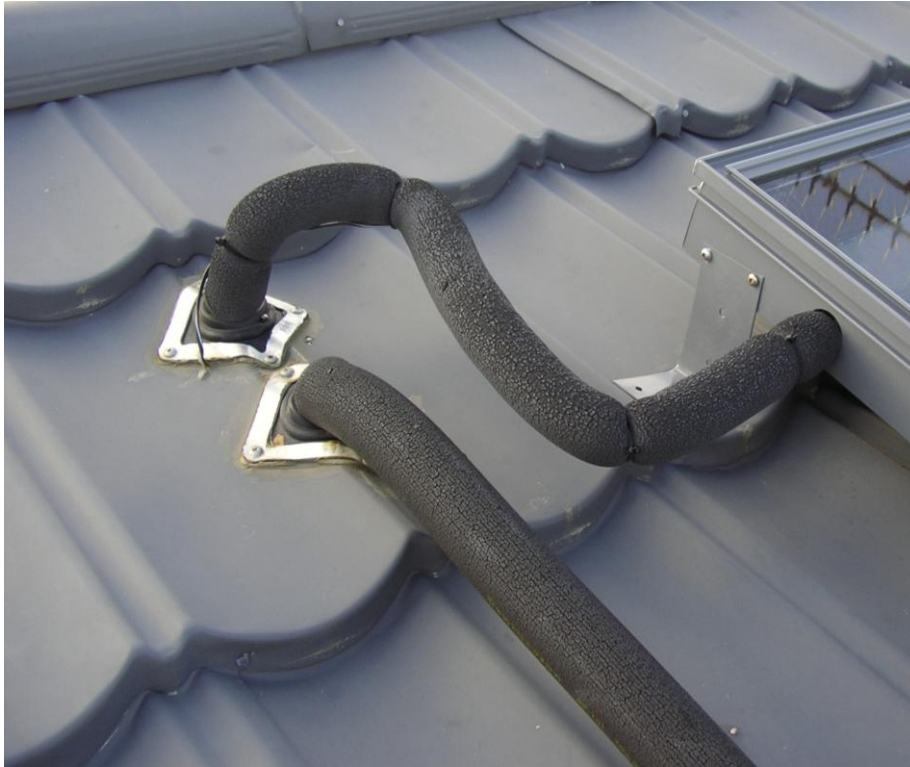
Figure 7. Note the checking of the surface of the lagging.

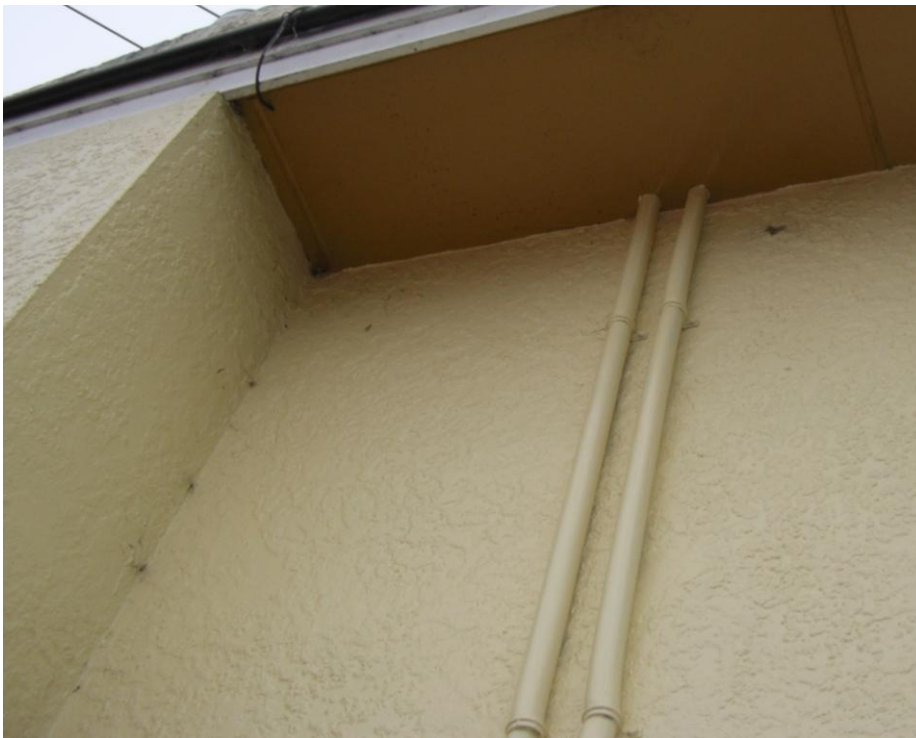
Figure 8. This lagging (north wall) has been painted – no UV damage.

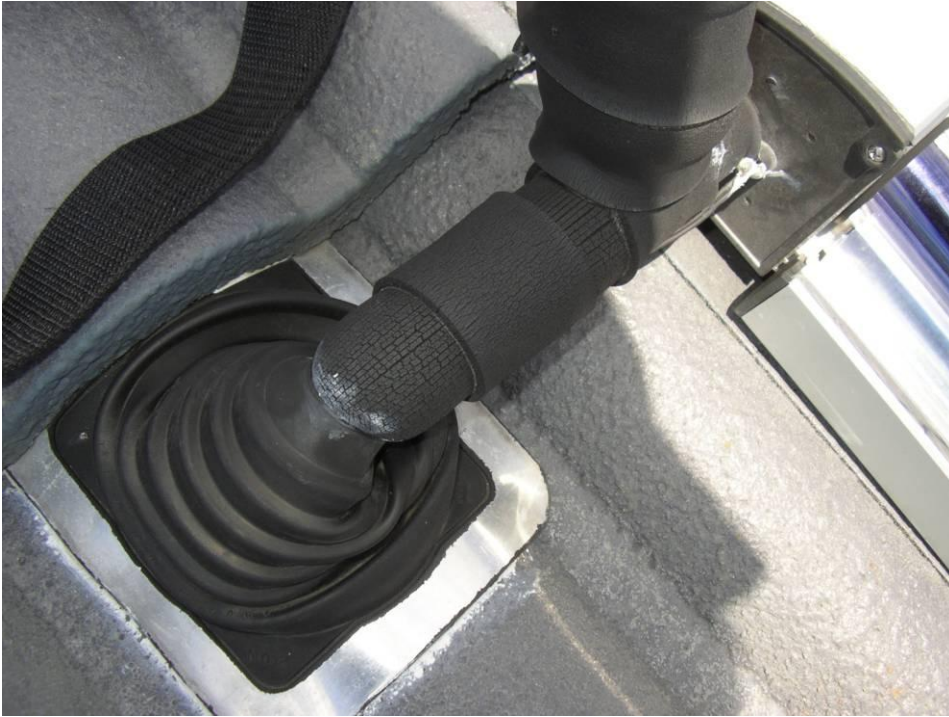
Figure 9. This is a very tidy job, but needs UV protection.

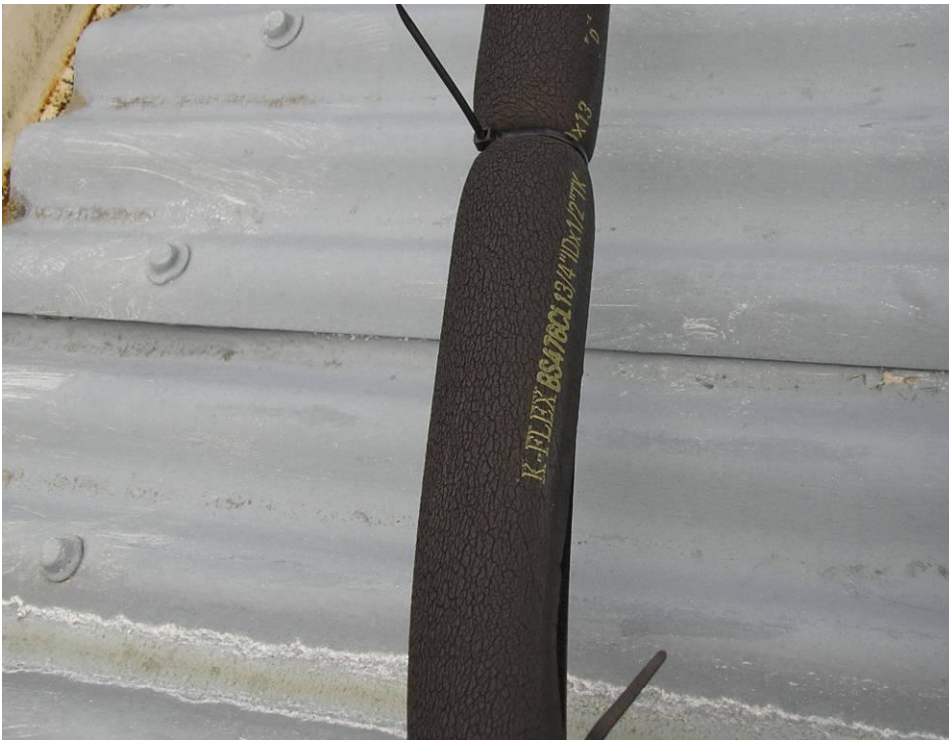
Figure 10. Surface checking,

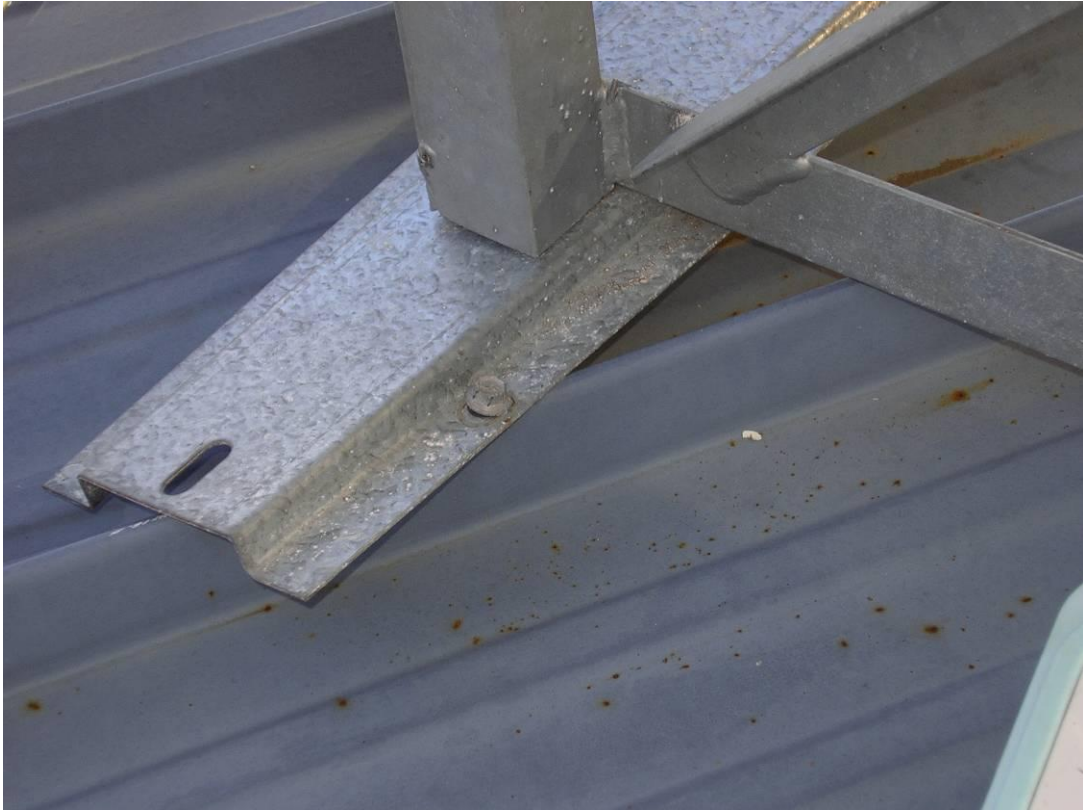
Figure 11. Note rusty swarf. See also Figures 19 & 42

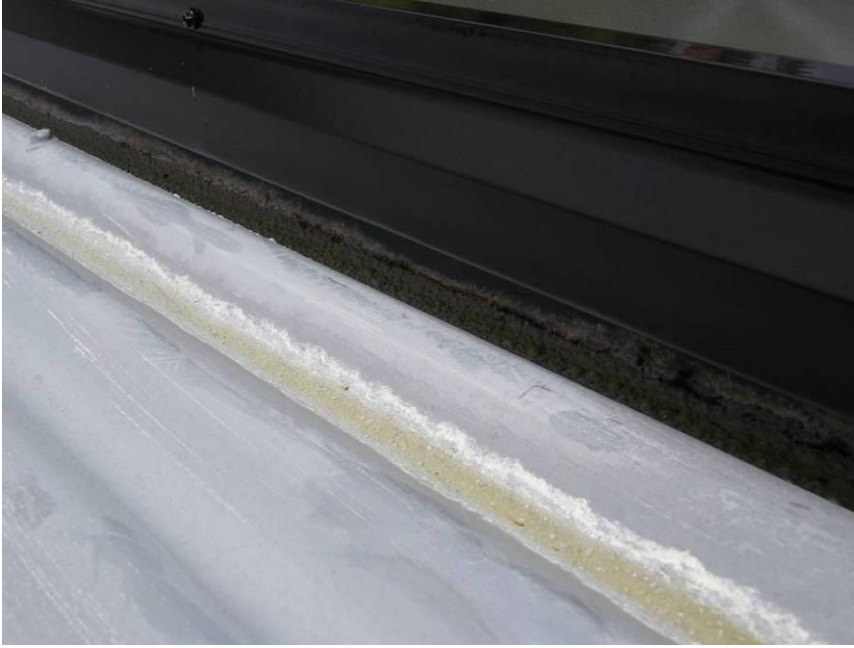
Figure 12. The edge of the collector frame has corroded due to the leaky washer.

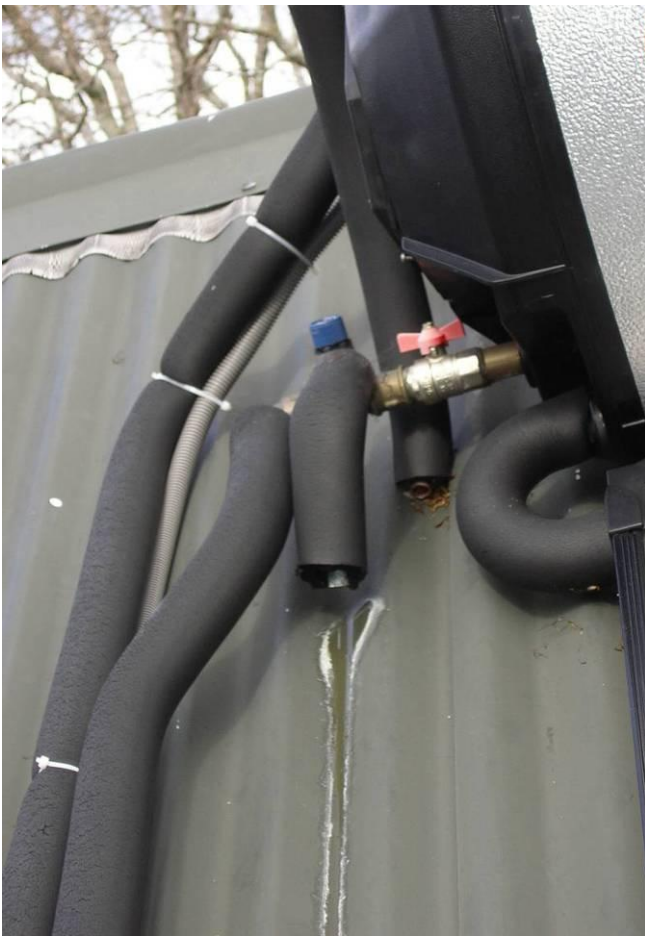
Figure 13. Cold water expansion valve in copper pipe has caused corrosion lower on roof.

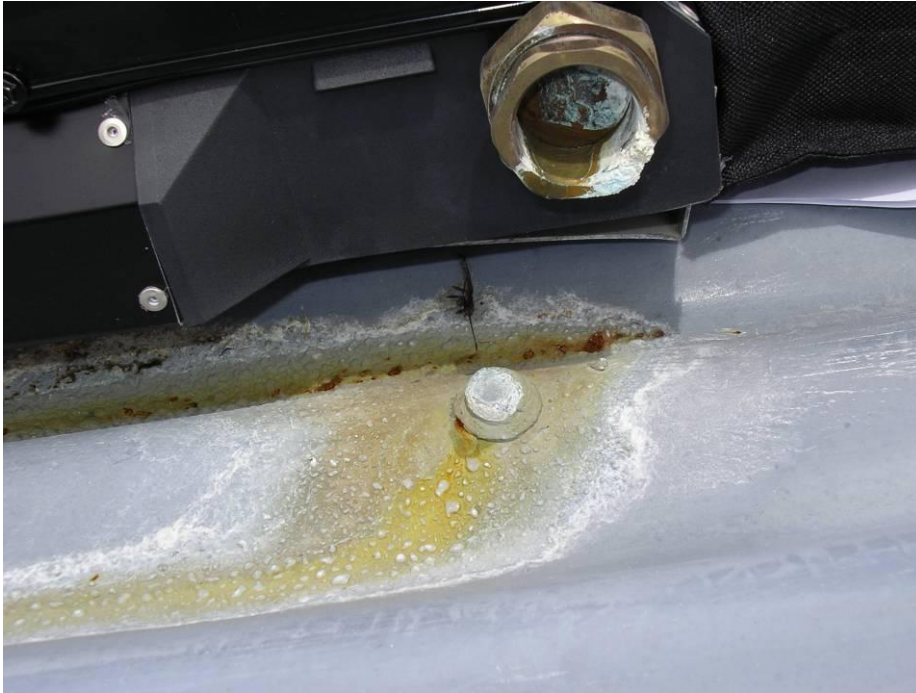
Figure 14. Leaky washer has caused corrosion of roof.

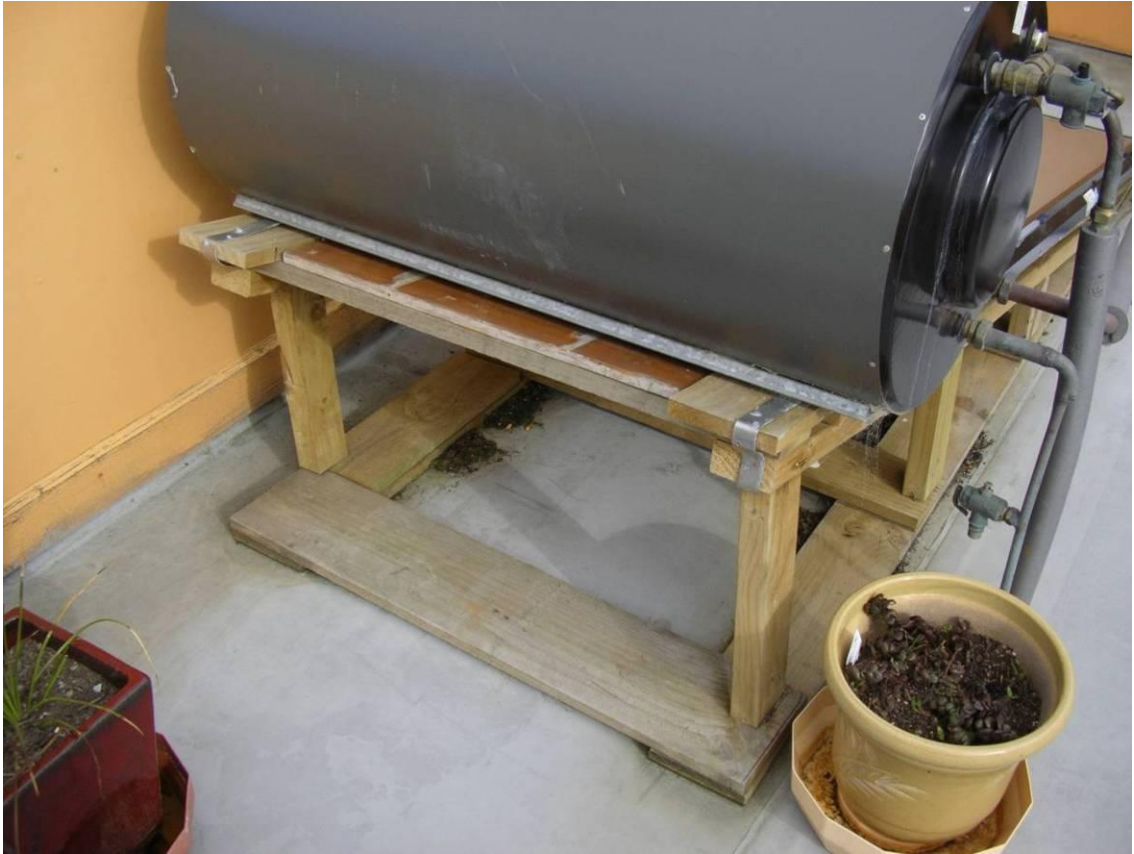
Figure 15. This tank frame is not mechanically held down at all.

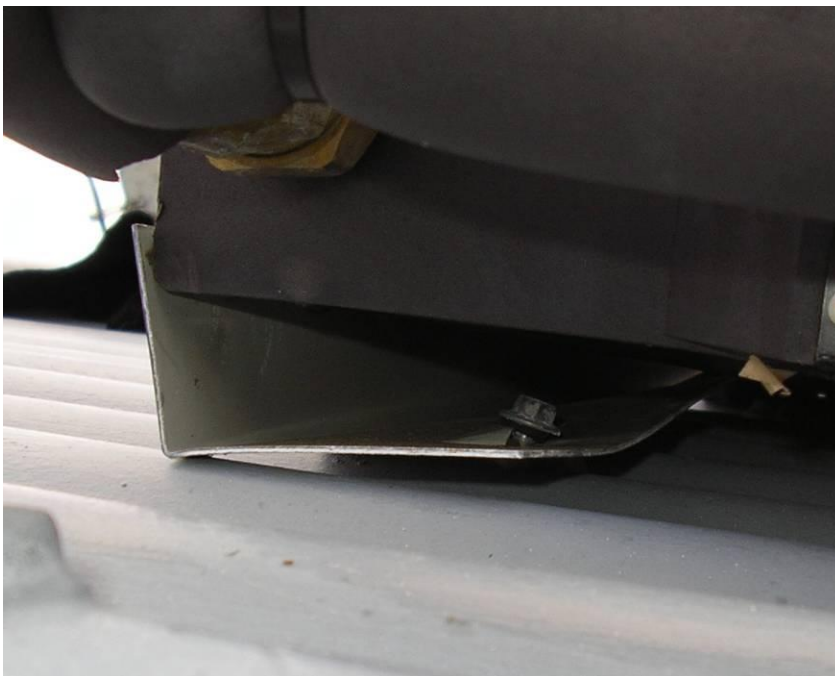
Figure 16. This screw is neither tight nor well-aimed.

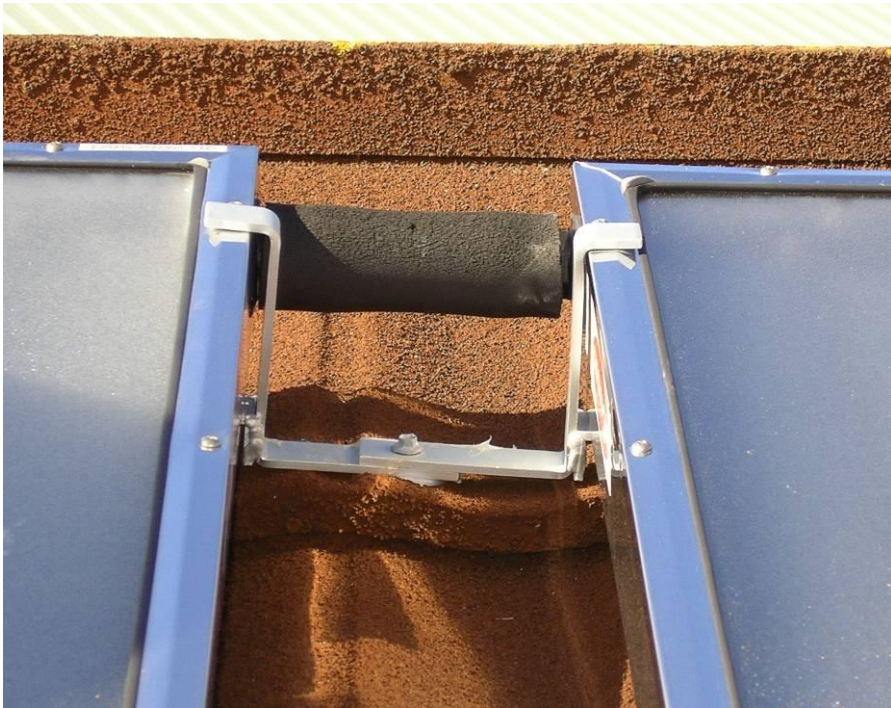
Figure 17. Good to see connect pipe lagged – but needs UV protection

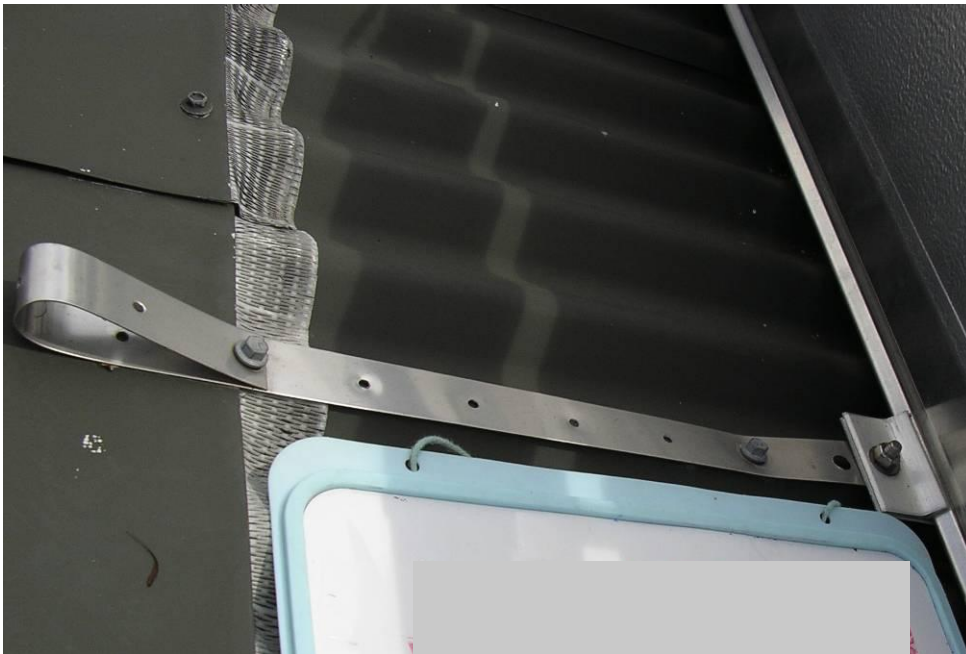
Figure 18. It is not clear whether the left fastener is tight.

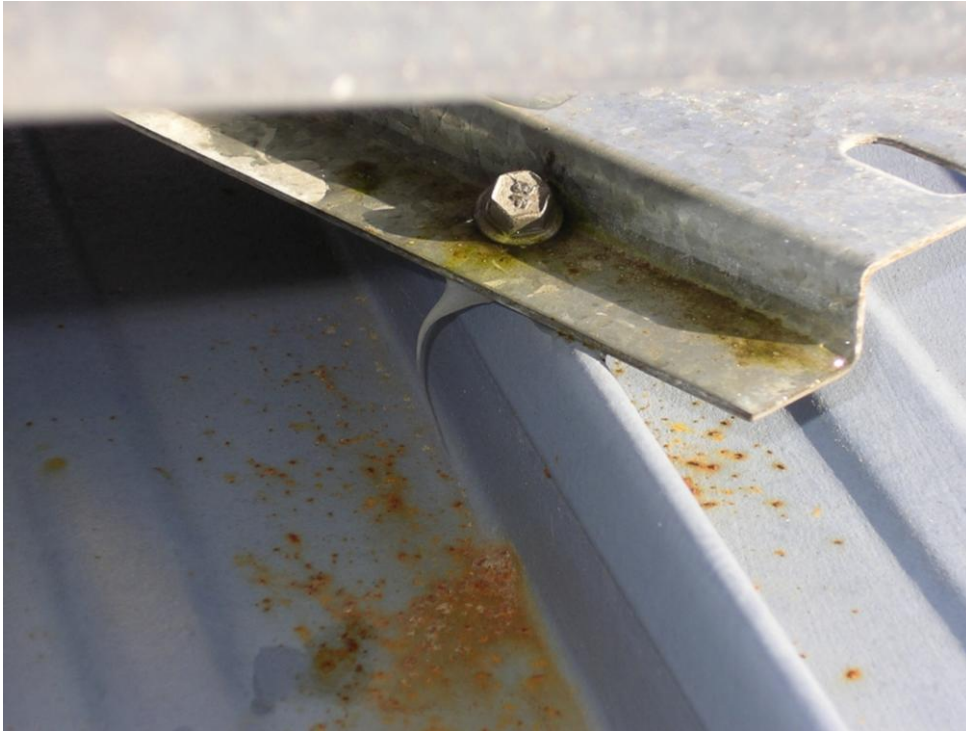
Figure 19. Four screws hold this tank/frame/collector onto the roof – each like this.

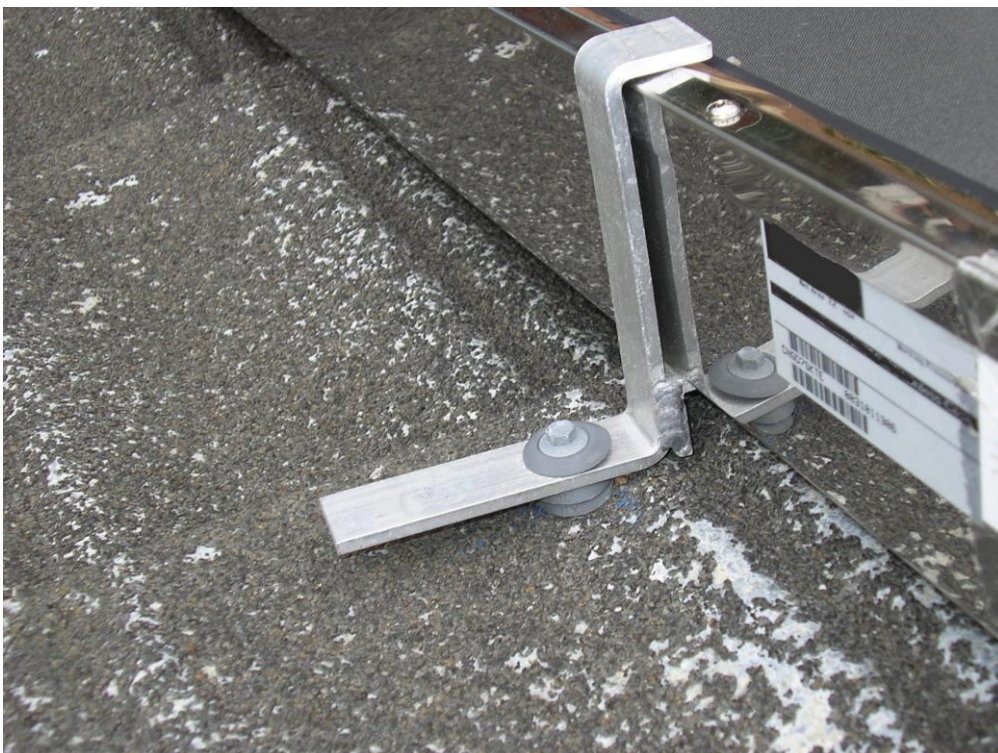
Figure 20. It is uncertain whether this bracket is tight on the stack of isolating washers.

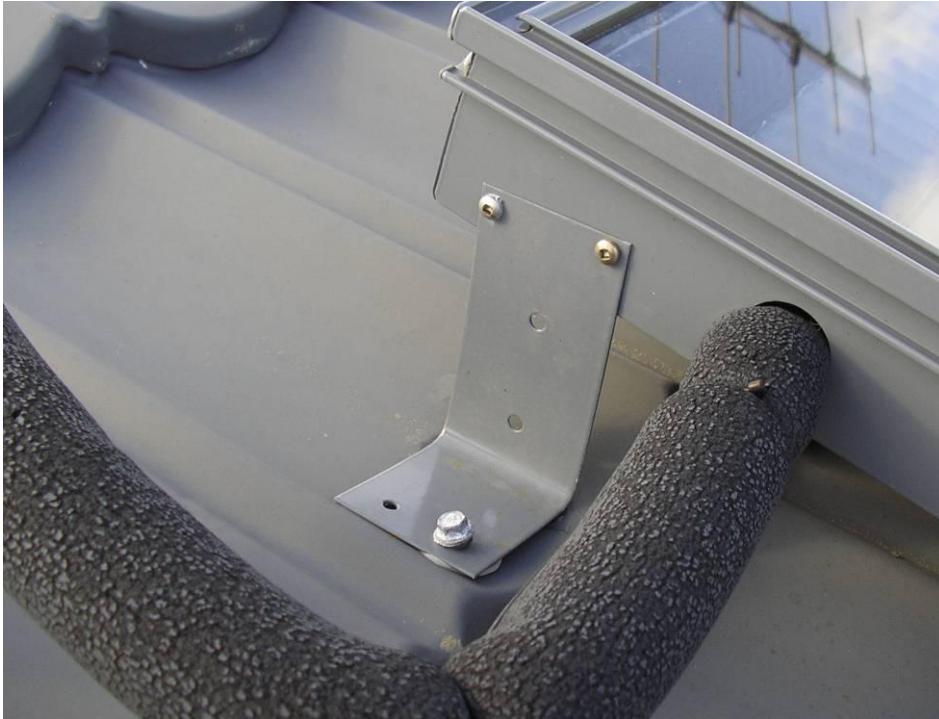
Figure 21. This collector has one screw at each top corner. The sharp bracket is touching the roof, despite the isolating washer.

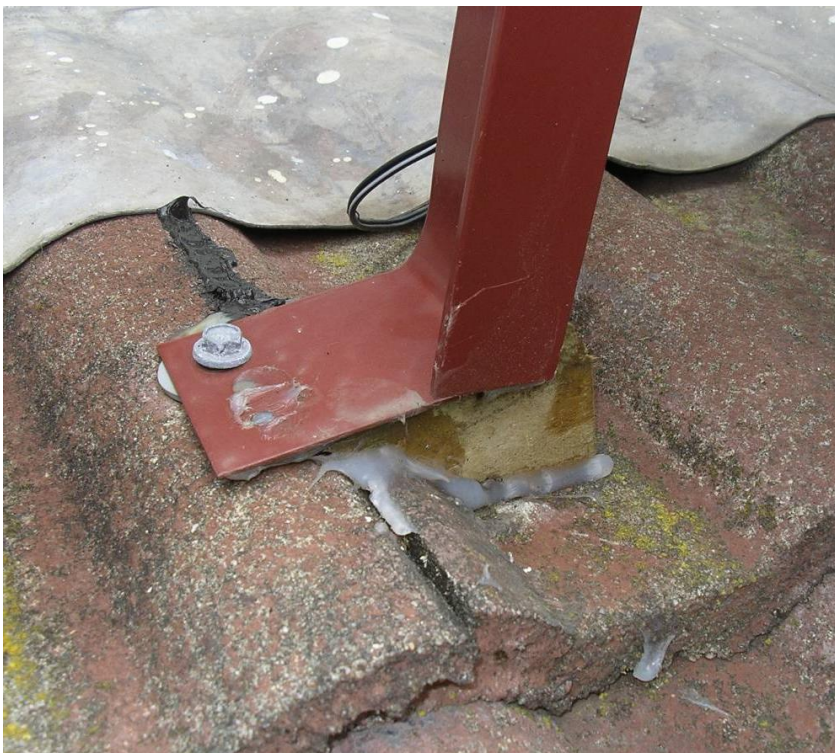
Figure 22. Fibrous board will swell further and bend bracket/break tiles.

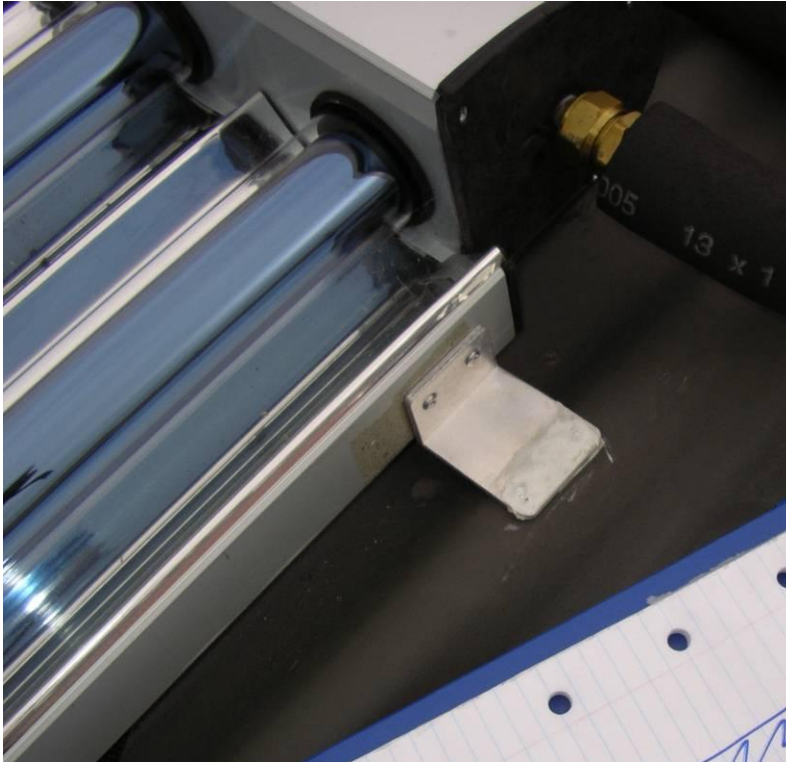
Figure 23. Aluminium angle held to roof with pop rivets.

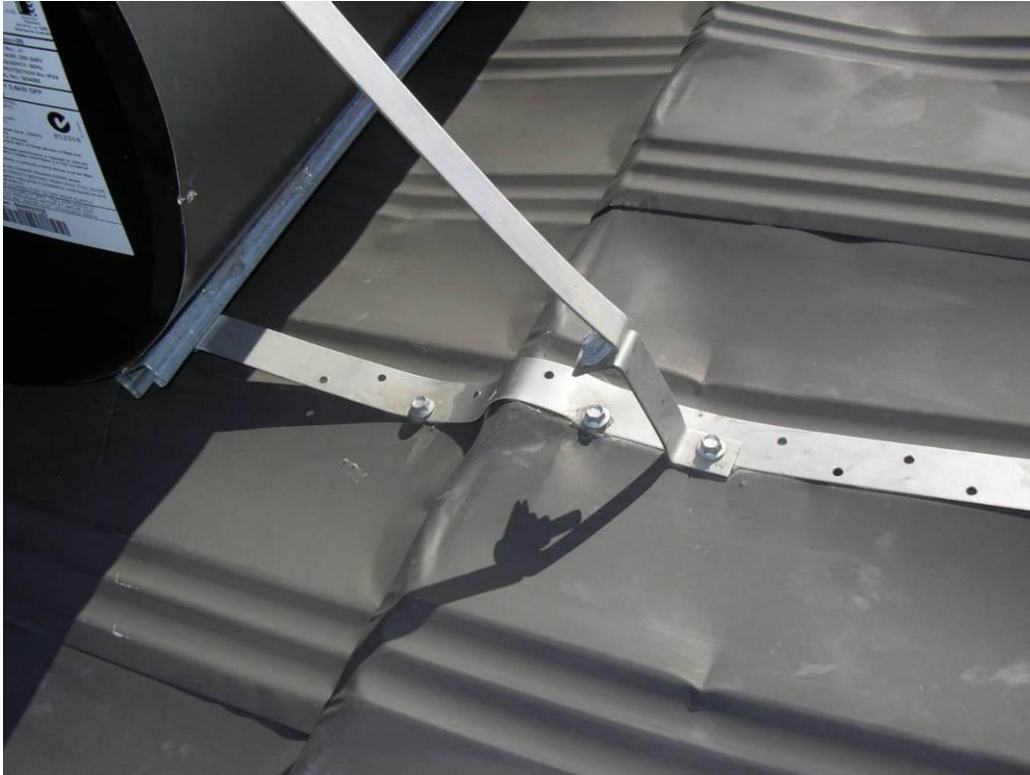
Figure 24. Stainless steel straps, sharp edges, galvanised screws, in contact with damaged roof.

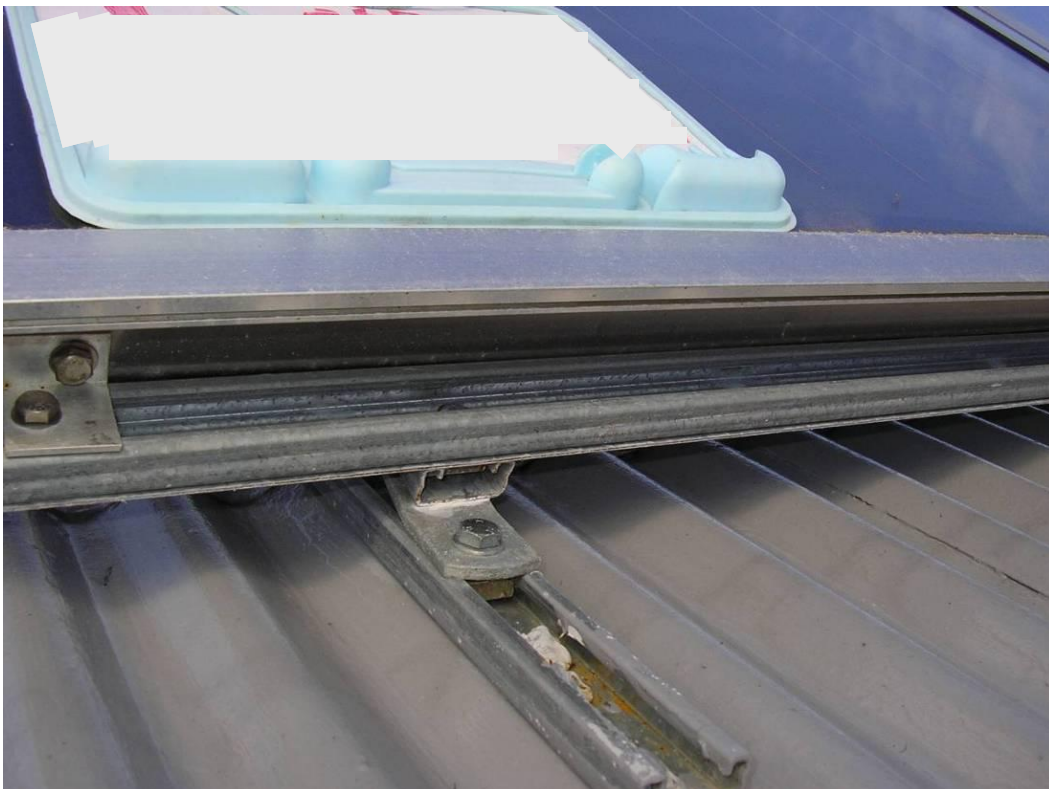
Figure 25. Galvanised brackets and stainless steel screws – channel not separated from roof.

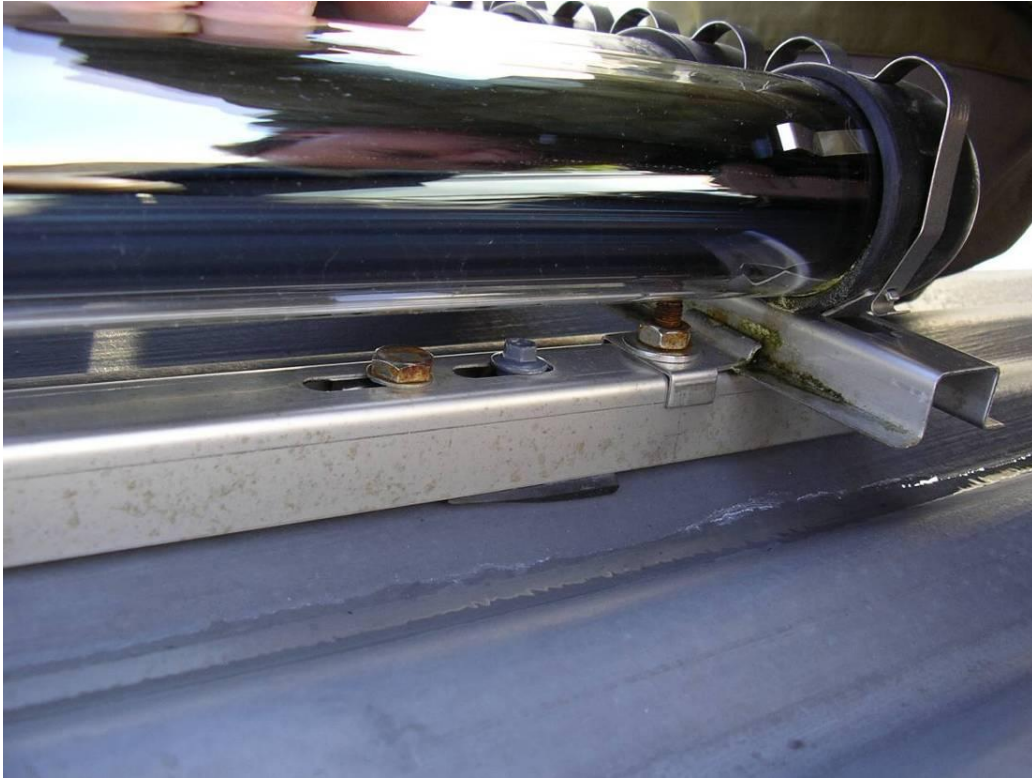
Figure 26. Separator under stainless steel channel – rust on stainless steel bolts is manufacturing fault.

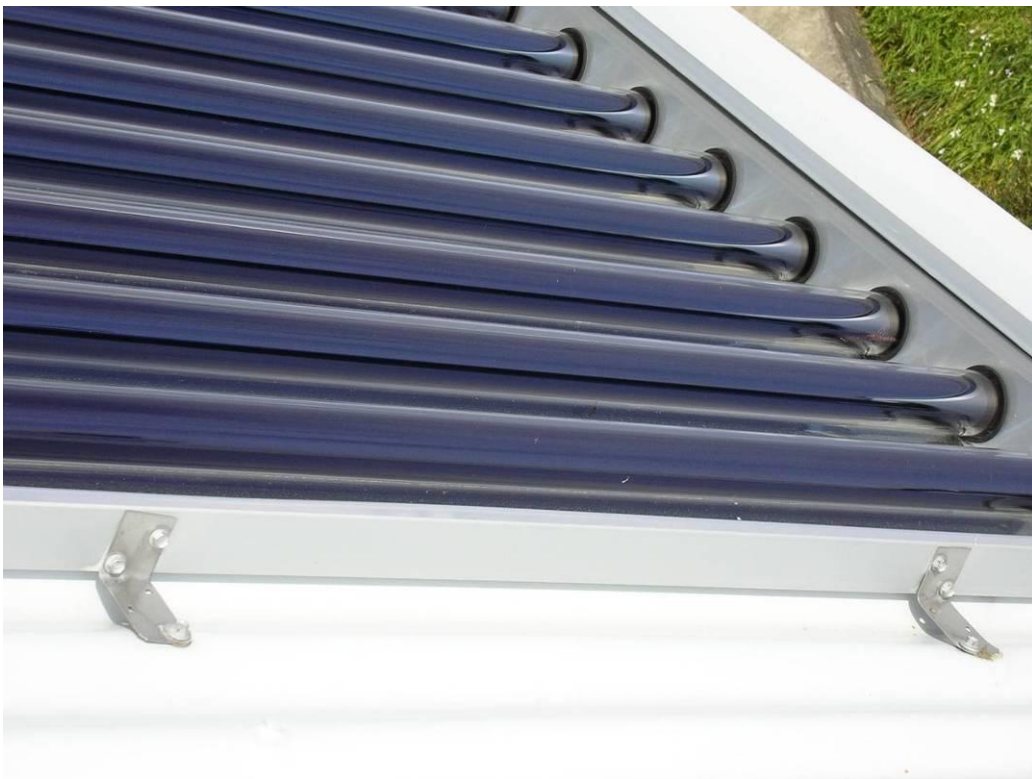
Figure 27. Stainless steel brackets with galvanised screws and separators.

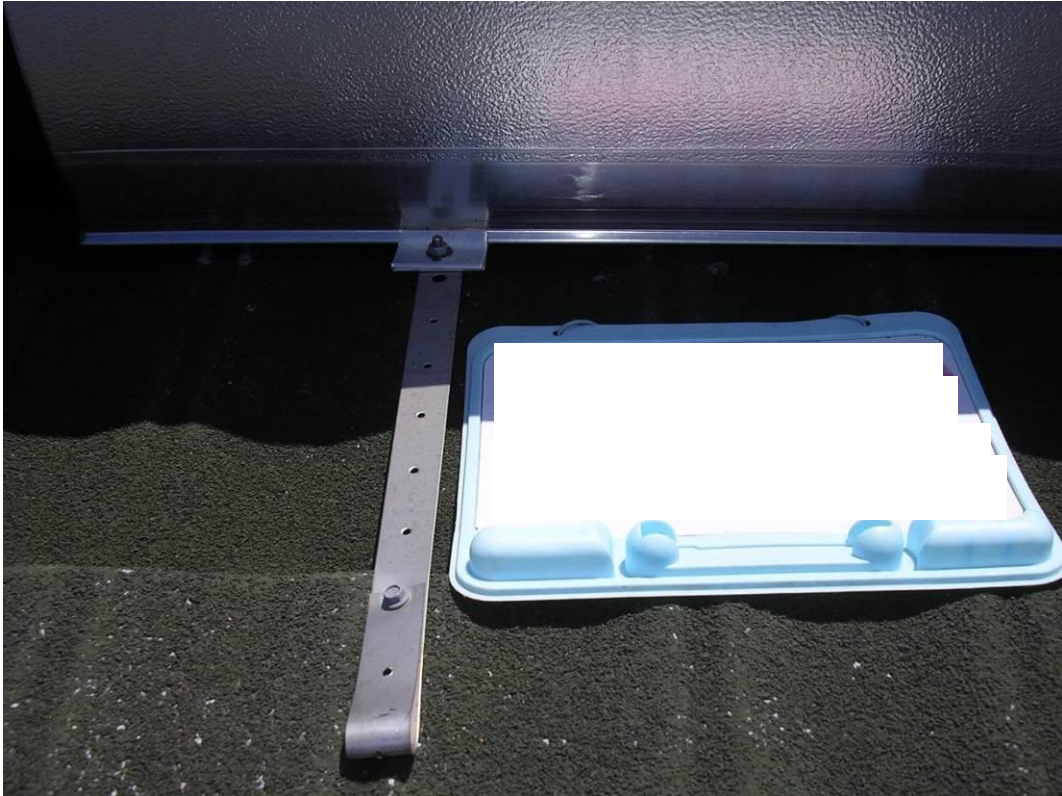
Figure 28. Stainless steel strap, galvanized screws, zinc and chip-coated roof, no separator.

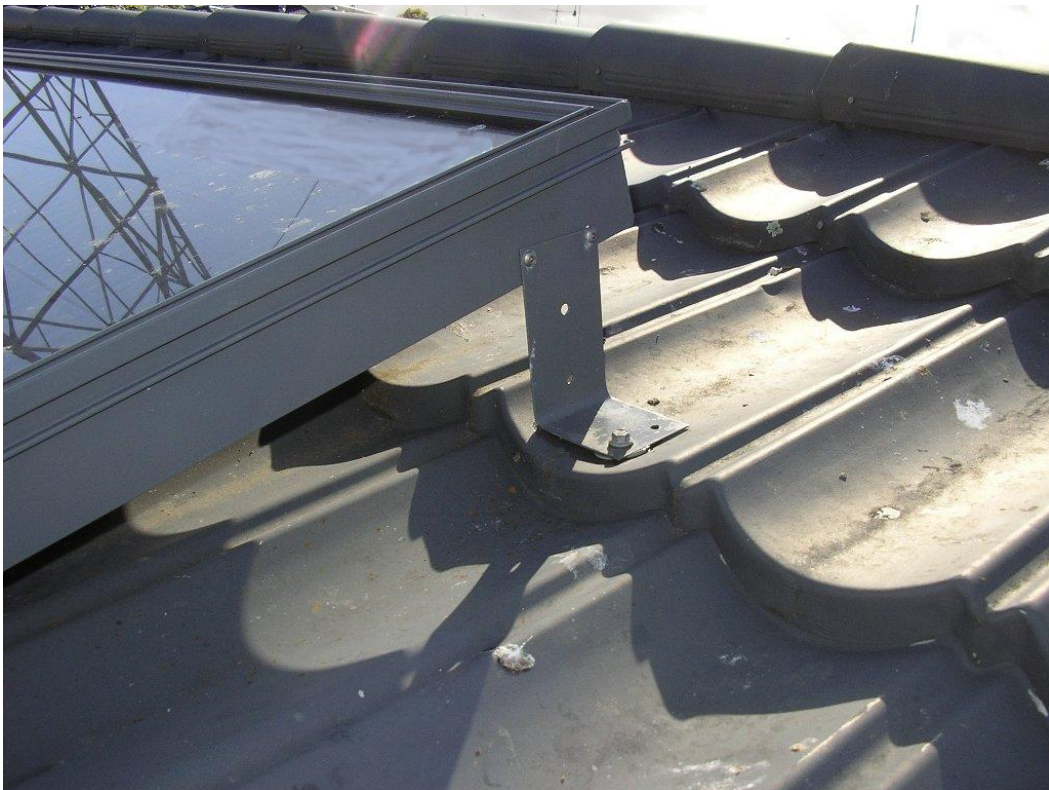
Figure 29. Painted steel bracket, with sharp edges touching roof despite separator.

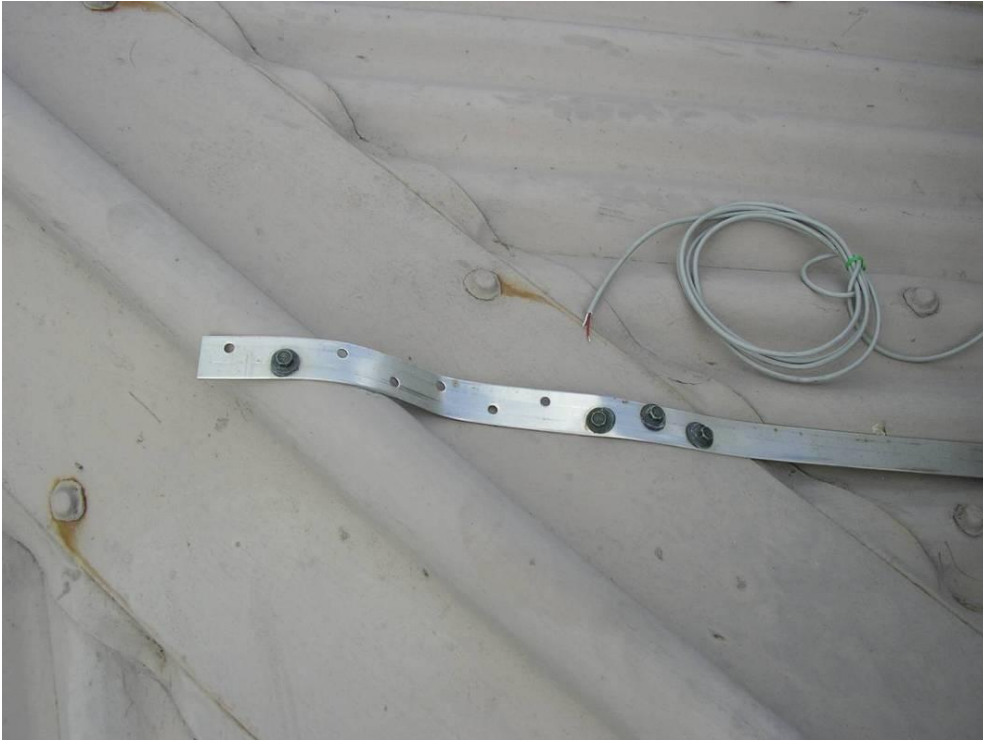
Figure 30. Painted galvanised screws, stainless steel strap, painted roofing, no separators.

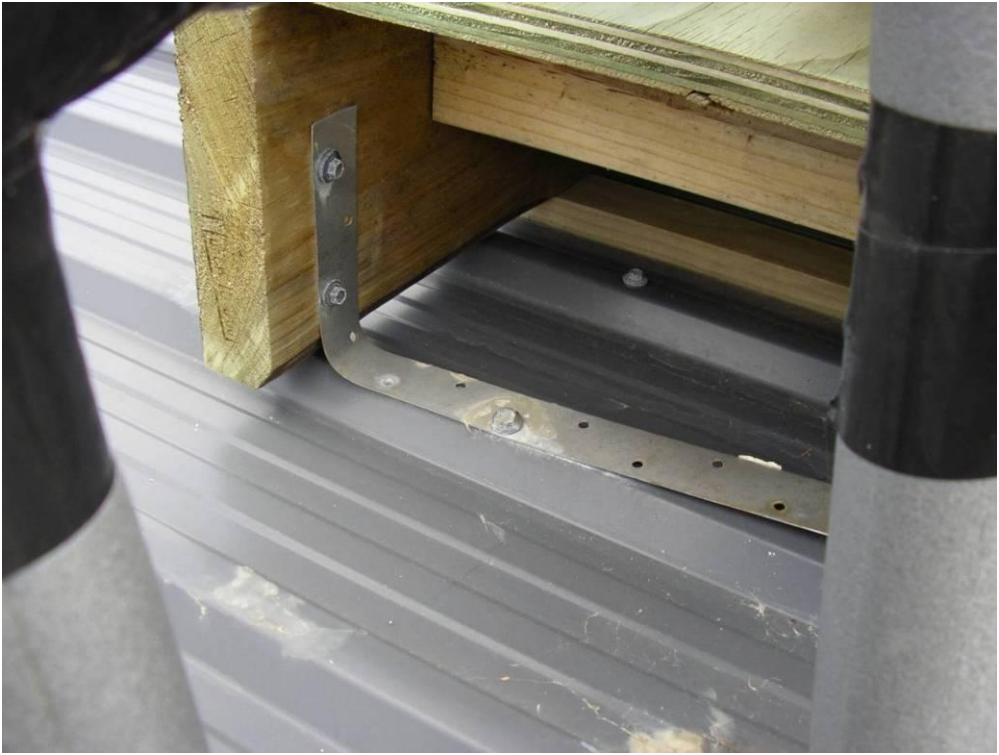
Figure 31. Stainless steel strap, galvanised screws, treated timber (holds moisture).

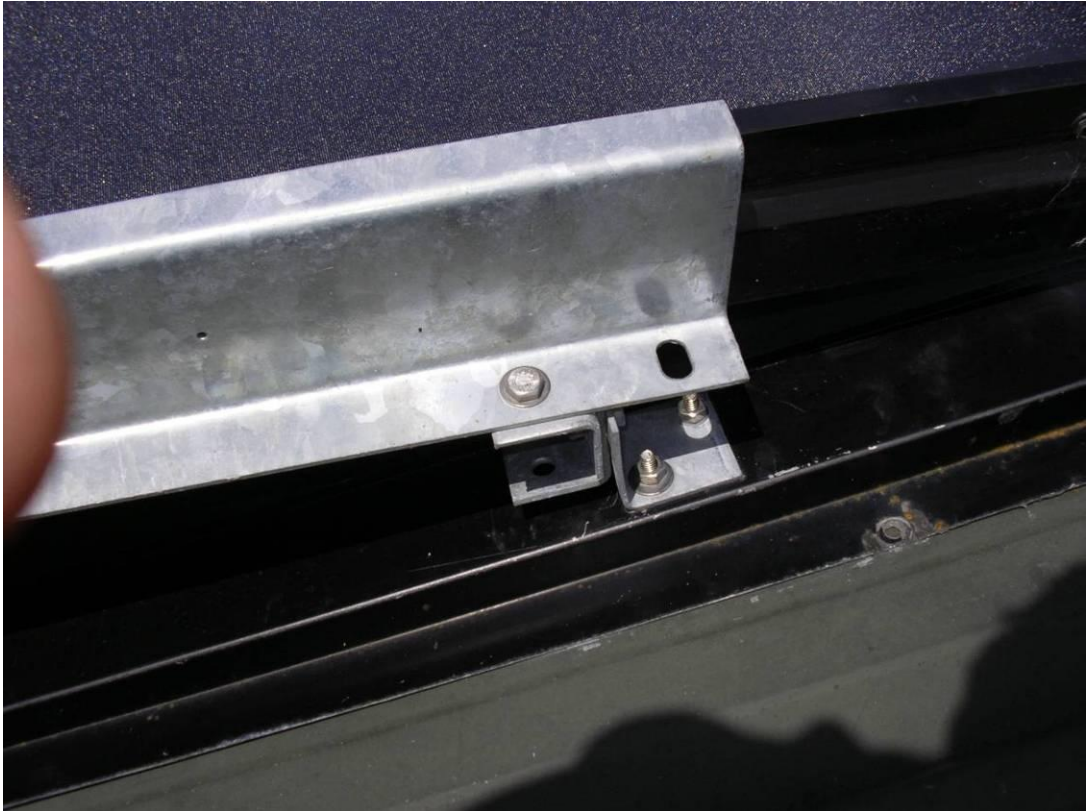
Figure 32. Stainless steel bolts, galvanised steel roof and brackets, no separators.
