STUDY REPORT

No. 184 (2007)

An Inspection of Solar Water Heater Installations

C D Kane, A R Pollard and J Zhao

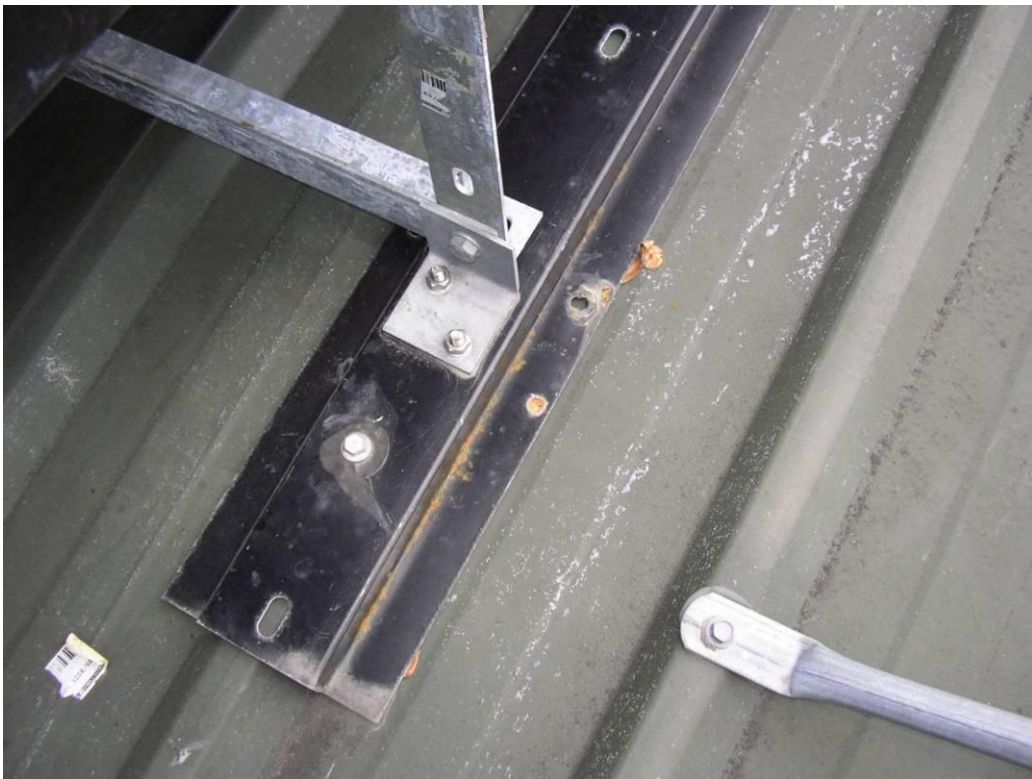
Figure 33. Stainless steel bolts, galvanised steel roof and brackets, no separators.

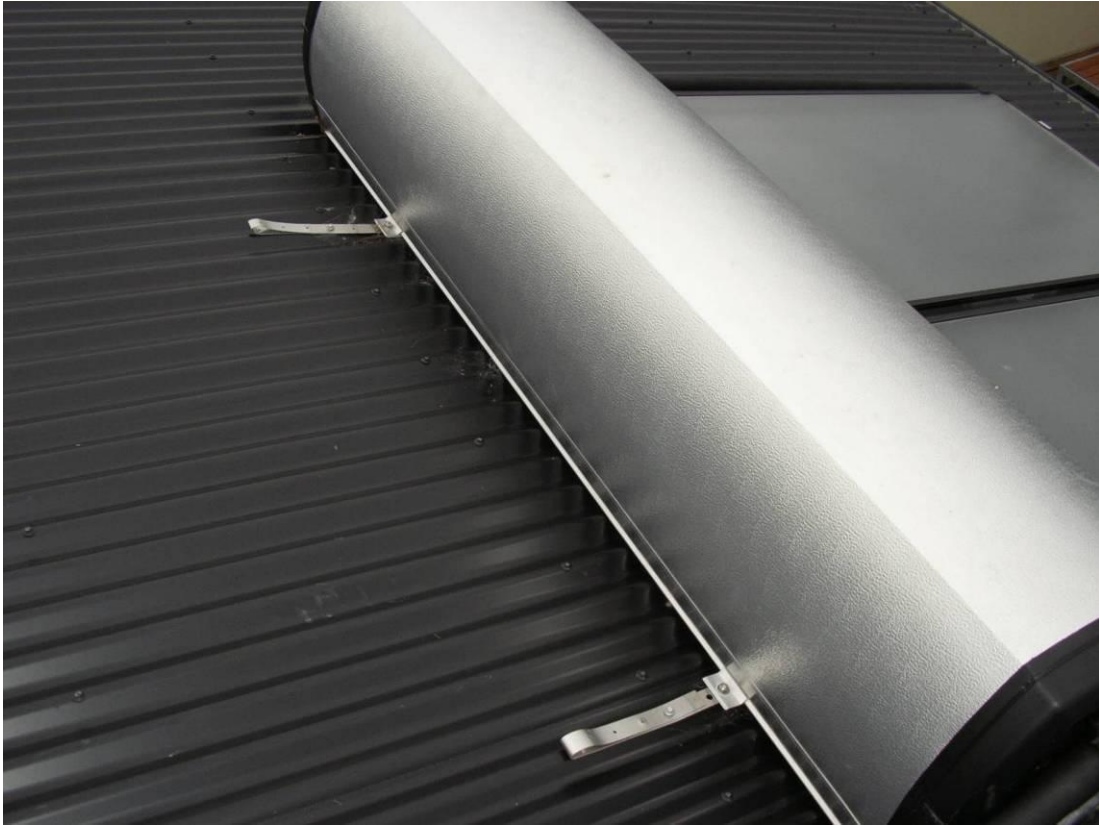
Figure 34. Stainless steel straps with zinc-coated screws used unseparated from a coated zinc-aluminium alloy roof – if the paint coating is broken, corrosion of the roofing will occur.

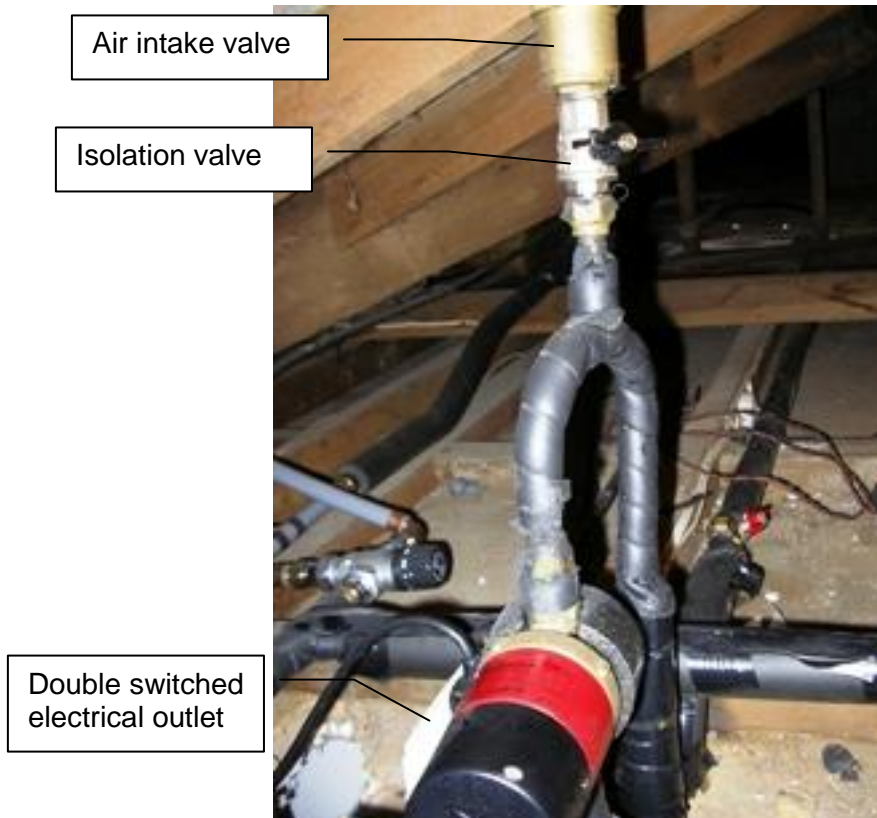
Another hazard partly visible in Figure 40 is the electrical outlet pointing upwards immediately to the left of the red pump. When the air intake valve is discharging steam this can cause water to come into contact with the outlet.

Figure 40. Air intake valve located in roofspace.

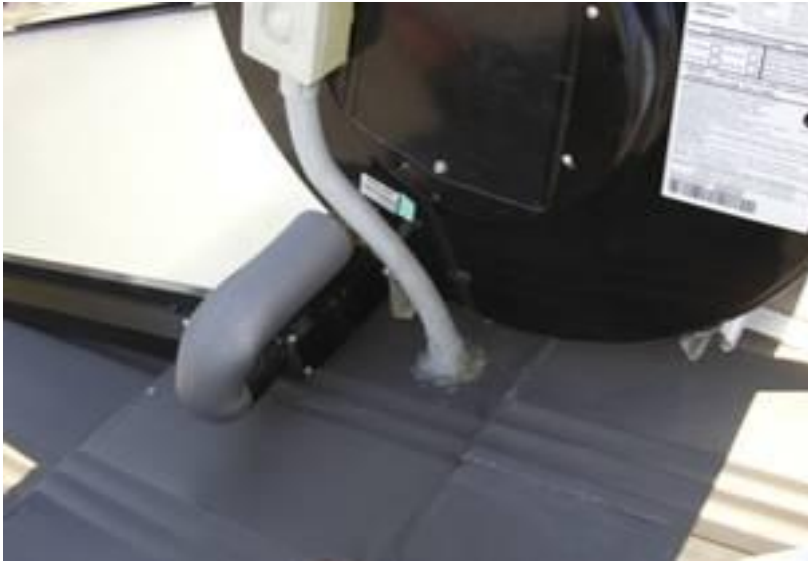
Figure 41. Good use of an electrical isolation switch glued to the exterior of a roof-top cylinder. Note, however, the poor flashing for the conduit passing through the roof.

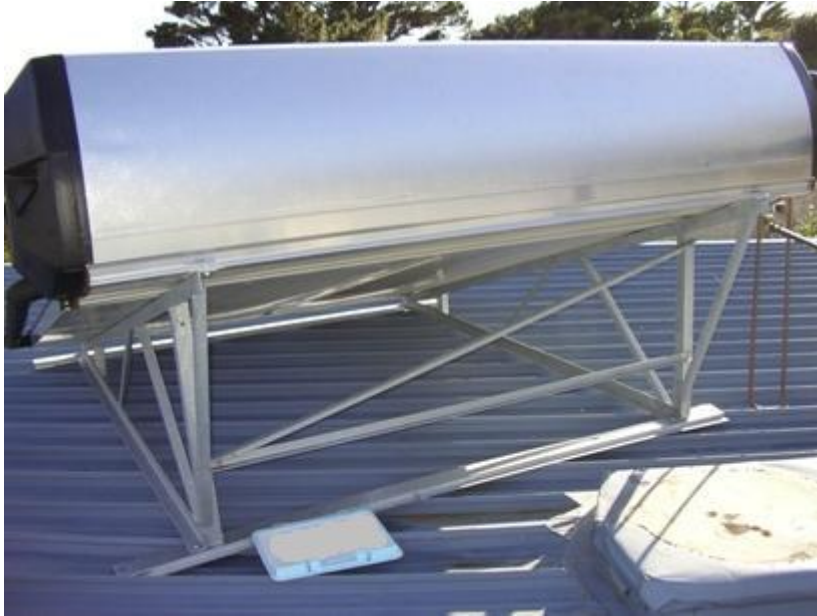
Figure 42. Poorly secured roof-top system.

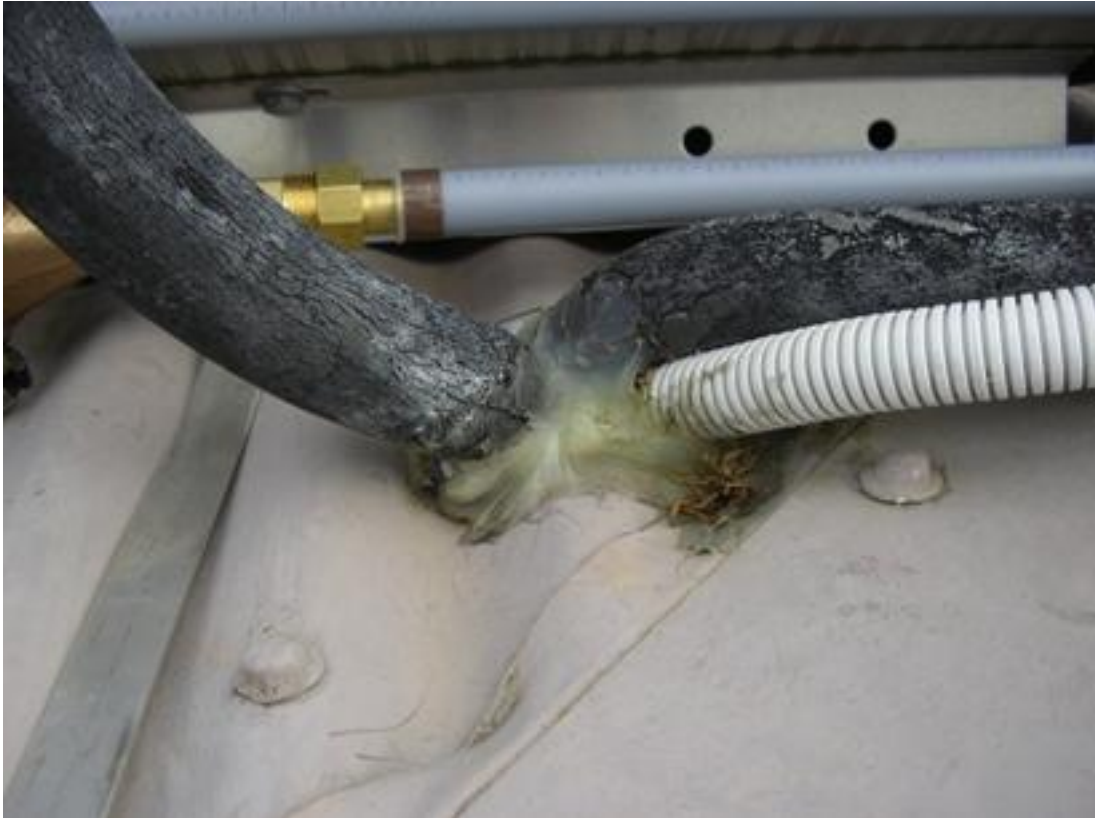
Figure 43. Degradation of lagging, unprofessional penetration sealing.

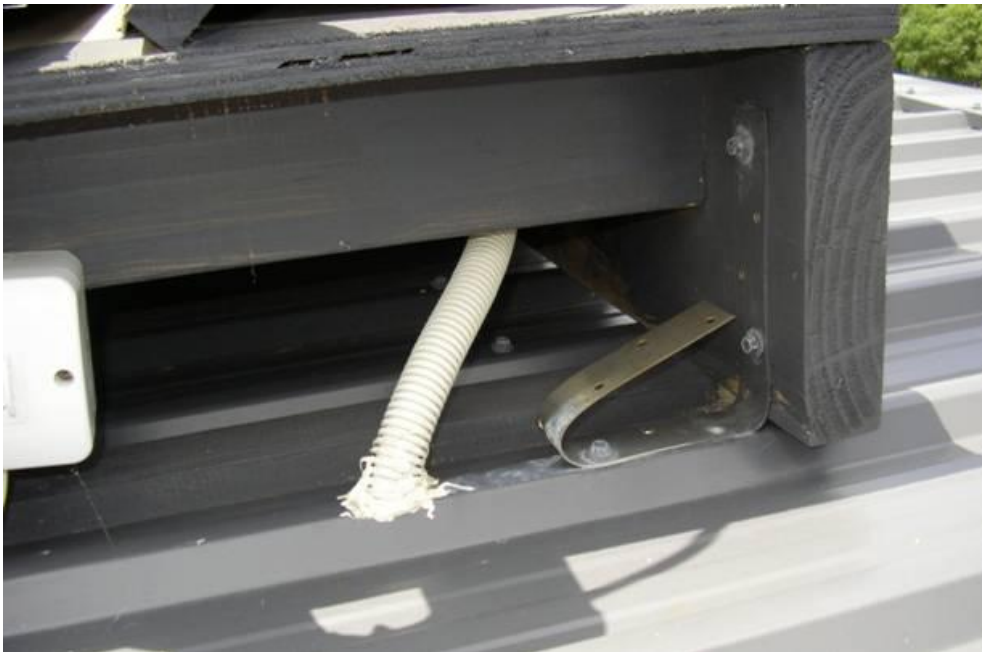
Dissimilar metals used in holding the collector units (and collector/tank units) to the roof will cause accelerated corrosion. Figure 44 shows this in some detail, with a stainless steel strap held directly to coil-coated zinc/aluminium-coated roofing with a galvanised “Tek” screw. Note the white area around the screw, which is caused by zinc corrosion products. There is no separating strip under the strap, so the point at which the screw penetrates the roofing will corrode more rapidly due to the presence of the stainless steel. There is a secondary issue here, which is that the timber on the roof will hold water against the roofing, accelerating the corrosion.

Figure 44. Dissimilar metals in contact, unprofessional penetration sealing.

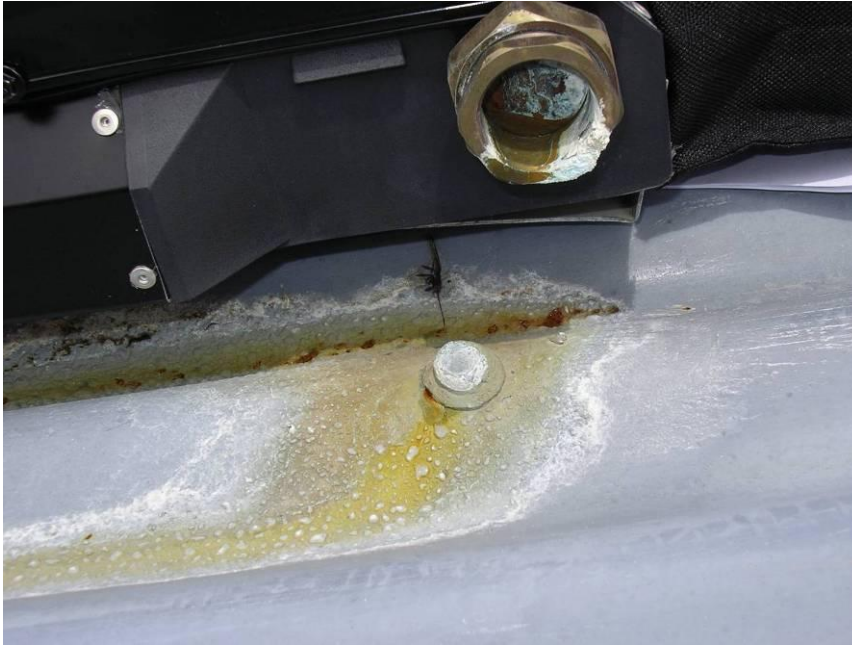
Run-off from plumbing fittings containing copper, in addition to that from the collector elements themselves via leaks, will cause corrosion of galvanised, zinc/aluminium-coated and aluminium roofs. Figure 45 demonstrates this quite graphically. The leak was due to a degraded fibre washer behind the blanking plug. The owner was notified and the leak fixed before the installation of monitoring equipment commenced.

Figure 45. A leak has directed copper containing water onto the roof, corroding it.

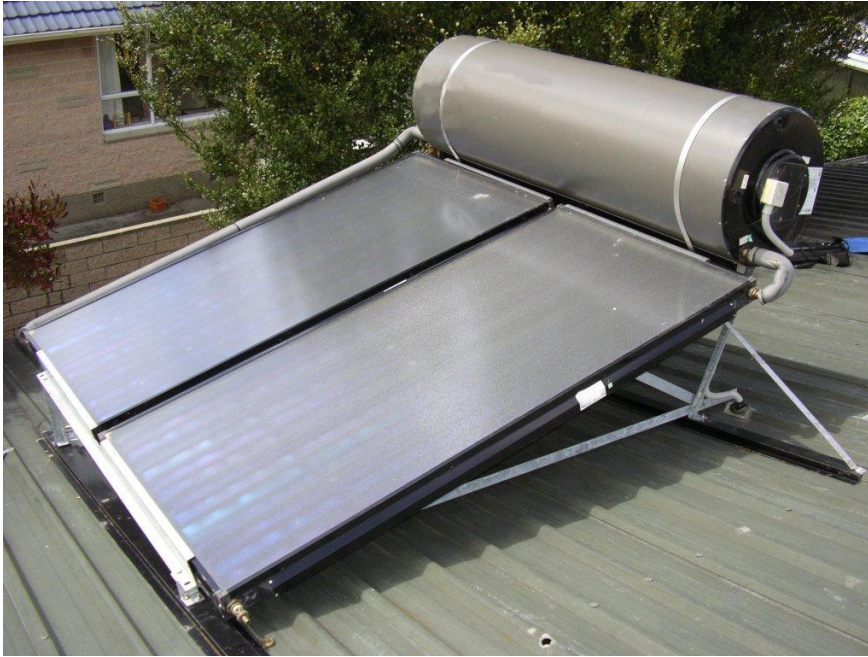
Sheltering from rainwashing will cause a build-up of salt and debris on the roof under the collector. If left unwashed, this can double the corrosion rate of the roofing. Figure 2 shows a large unwashed area under this panel. It will take several years for the corrosion damage to become apparent through a coil-coated or painted roof – by this stage significant remedial work will be necessary to the roofing. The solution is to wash the sheltered areas regularly with fresh water and a soft brush. Note also the hole in the foreground – this is a pipe penetration from the original installation of the unit – facing almost due east. The owners demanded a change of orientation and the unit was moved. The hole remains.

Figure 49. A large sheltered area exists under this collector.

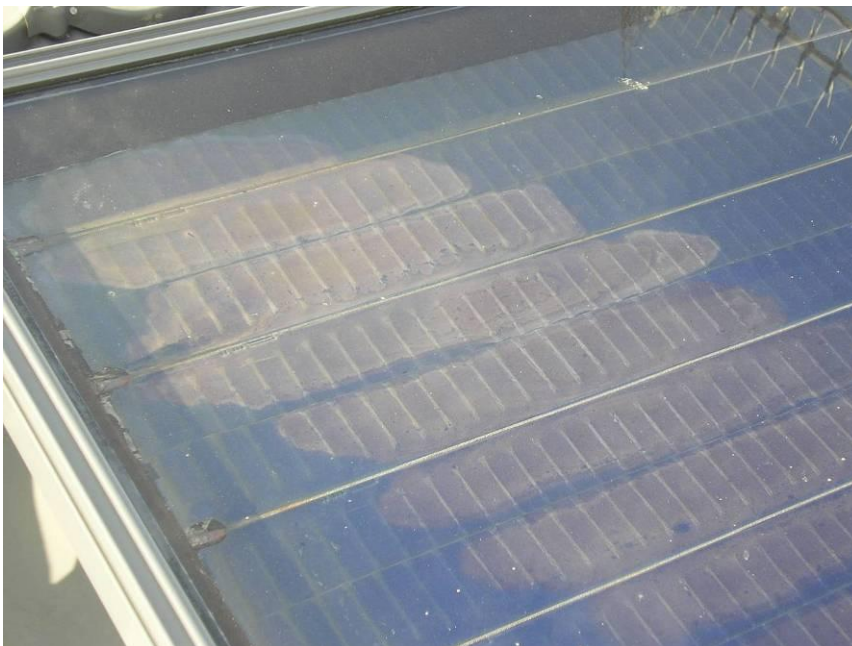
One unit was inspected which exhibited the discolouration of the collector surface seen in Figure 46. This did not appear to be corrosion *per se*, but rather a colour change, back to the natural copper colour. This collector is of the type which is cast into its insulating foam surround, the latter forming the rear part of the panel. This collector was actually loose in its frame and could be moved with the fingers. It is doubtful in this case that a still air gap would exist between the collector and the glass face, which would lead to efficiency losses. This collector is 11 months old. Another nearby unit of the same type and 16 months old did not show this discolouration or loose collector.

Figure 46. Discoloured collector.

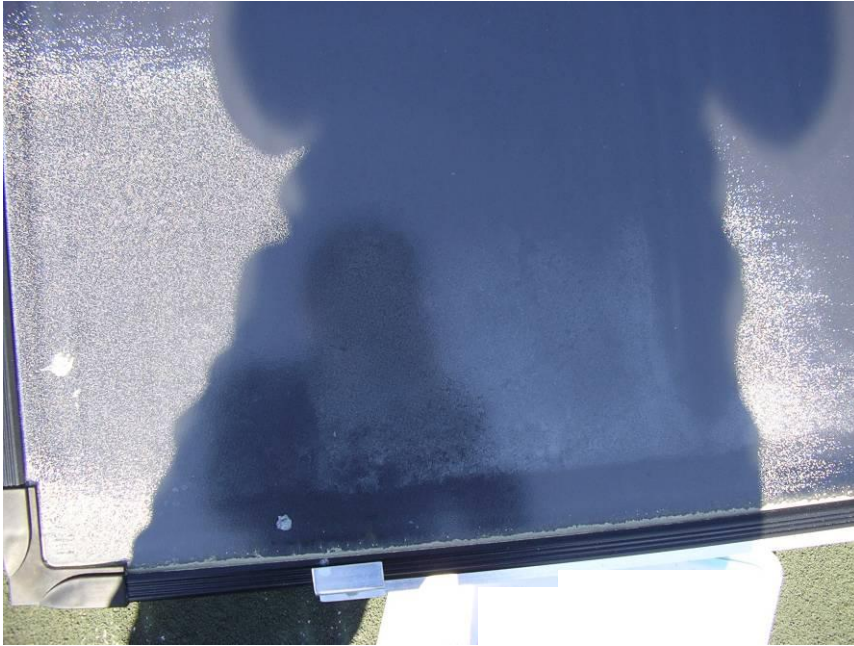
Figure 47. Condensation inside glass.

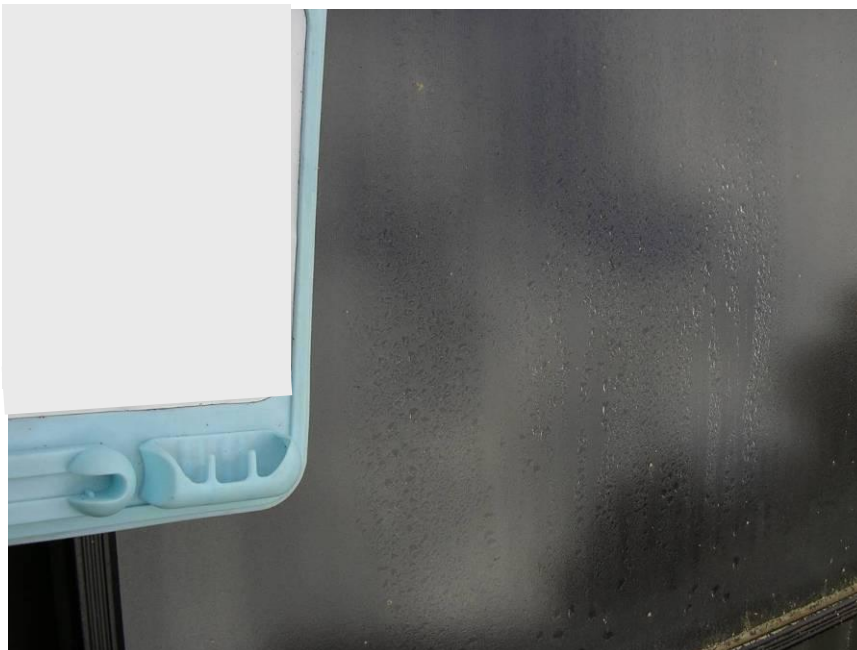
Figure 48. Condensation in collector.

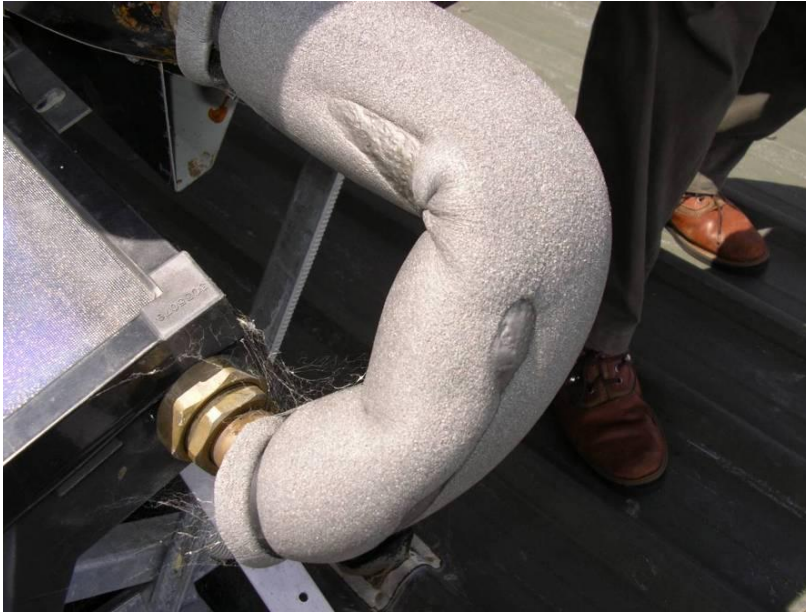
Incorrect lagging choice has led to this material melting in service. Foamed polyolefin lagging of this sort is not suitable for piping temperatures above 80°, although it is more durable when exposed to UV.

Figure 49. Melted lagging.

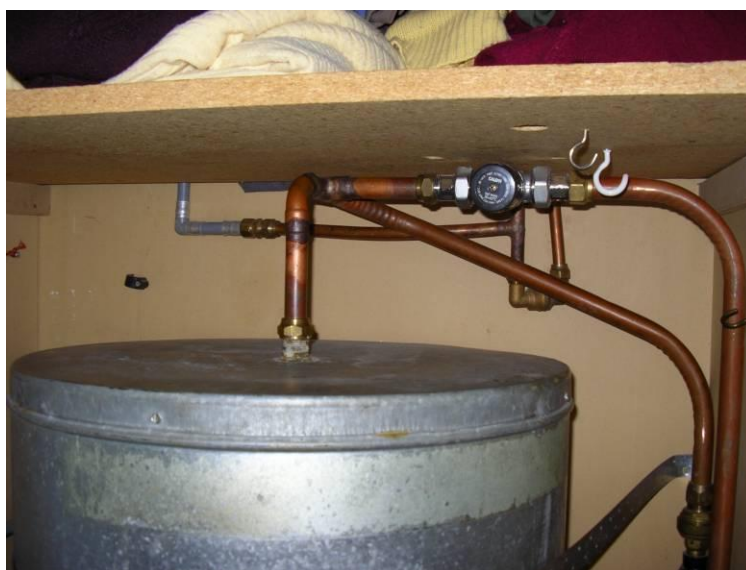
Figure 50. The tempering valve is fed from two hot supplies – the HWC and the SWH.

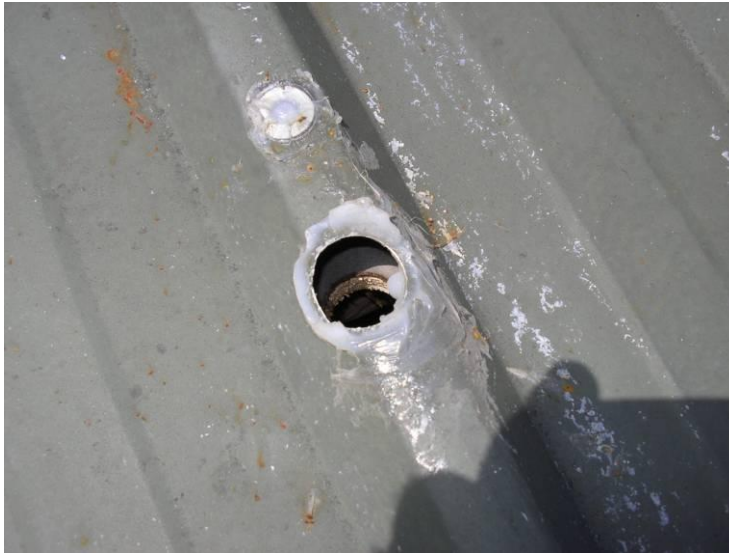
Figure 51. Hole left after reorienting collector by 90° – it is 25 mm in diameter.

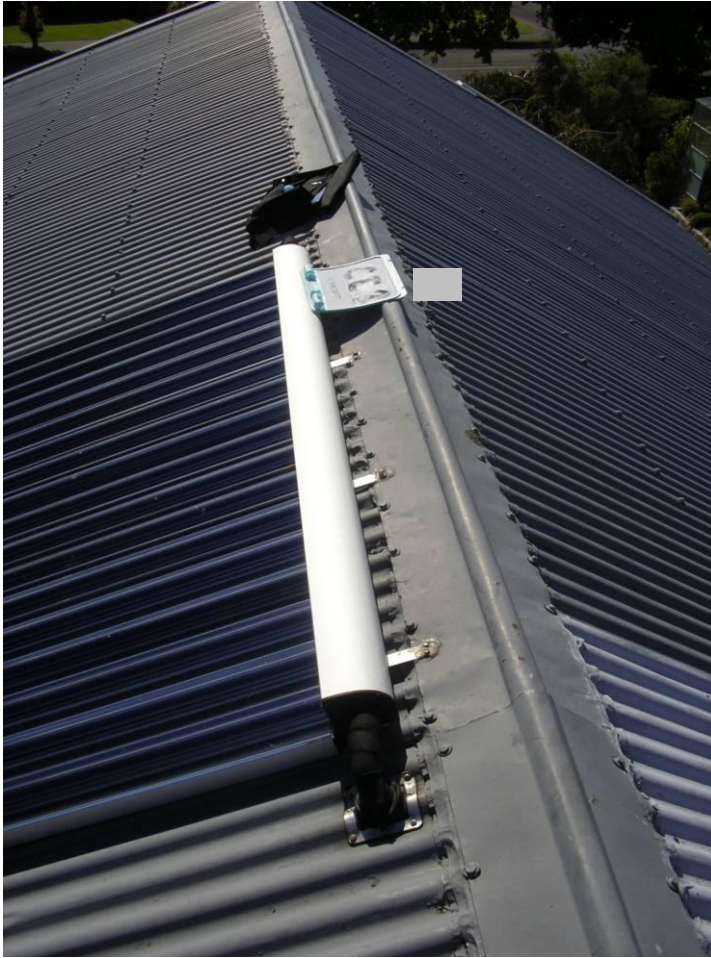
- The installation of over-temperature pressure and TPR valves is not consistent. Some installations appear to rely on a roof-top air admittance valve, whilst others depend on the TPR valve on the storage cylinder itself. There is no certainty that the solar loop is mechanically protected against an over-temperature incident – as an example, in one system the controller shut down the circulation to the collector when the temperature exceeded the over-temperature threshold. The stagnant collector was then unable to dump heat or pressure as there was no pressure relief at the collector or elsewhere in the solar loop.

Figure 52. Collector at 120°C – note the lack of relief valve.

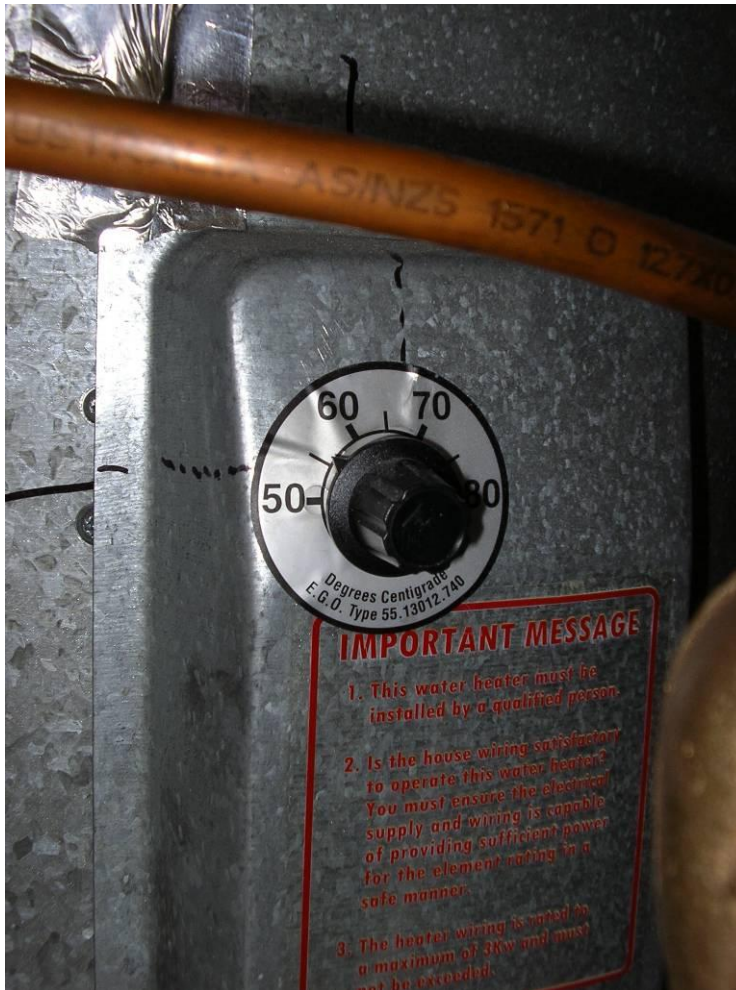
Figure 53. Thermostat set at 56°C as owner’s manual recommends.
