mirotherm[®] absorber fact book

This **mirotherm® absorber fact book** is filled with testimonials and examples from the solar thermal industry, and is intended to reinforce the quality and durability of aluminum laser welded solar thermal absorbers in our customers’ own words. We hope this book can serve as a best practice resource for the industry as well as a tool that can instill confidence amongst distributors, installers, end consumer, and stakeholders in emerging markets that laser welded aluminum absorbers are a reliable industrial product for the growing global solar thermal market.

2.1 Test Report No. X111

Customer: Wagner & Co. Solartechnik GmbH – Long term load testing:
Laser welded Cu-Alu absorber thermal-shock test procedure (on arrangement).

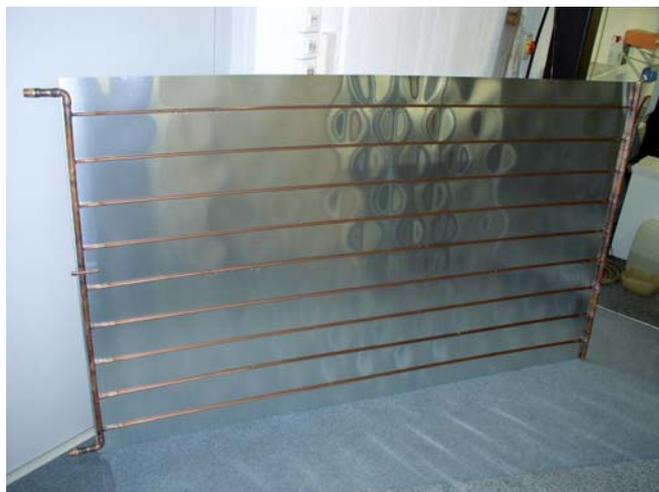
Figure 7: Rear side of absorber.

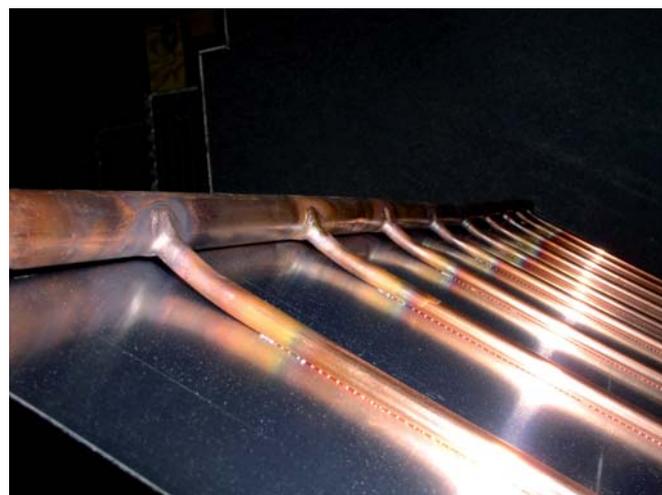
Figure 8: Mildly cranked copper pipe register.

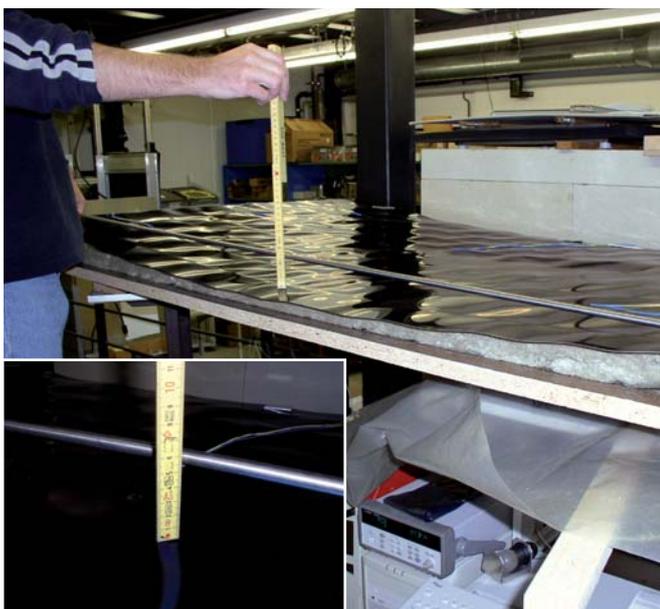
Figures 10 & 11: Significant dished deformation led to an overall curvature with a depth in the range of 5 - 6 cm.

As was observed with earlier experimentation, the crumpling of the aluminum sheet and the overall dished curvature resulting from the bimetallic thermal work stabilized within the first few cycles.

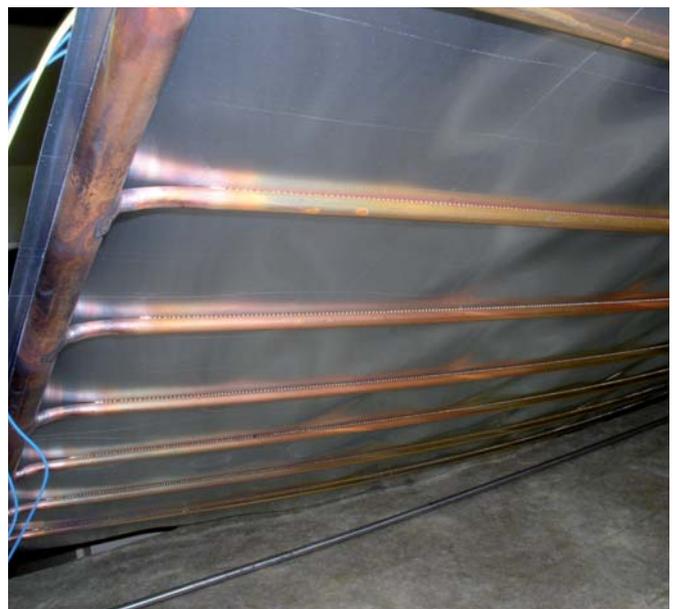
Figure 12: Backside of the absorber. All welded seams remain intact.

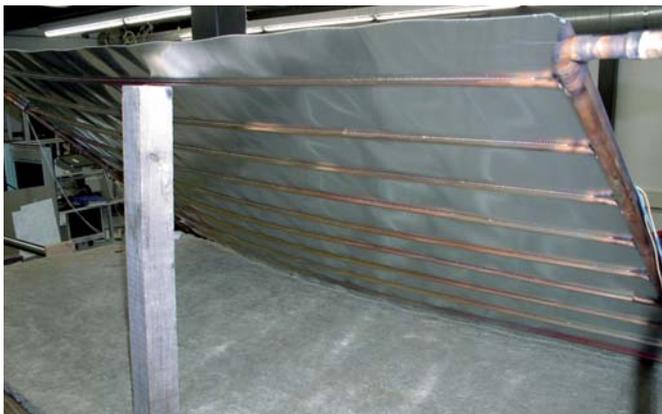
Figure 13: Backside of absorber following 1000th cycle.

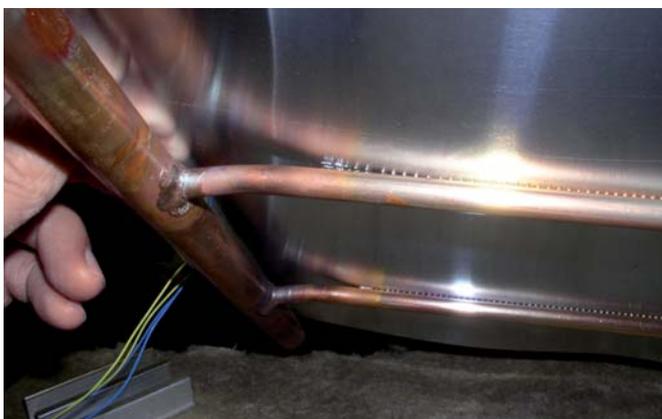
Figure 14: Mild separation of one of the ascending pipes.

A visual inspection was carried through following 1000 low temperature cycles. The welded seams appeared on (visual) inspection to be in order. On the end of one of the ascending pipes (Fig. 14) a mild delamination between aluminum sheet and copper pipe was apparent. Minor damage to the aluminum sheet was detected (Fig. 15) on closer inspection of the end of all welded seams. Given additional force or longer strain times these weaknesses could lead to larger scale flaws (crack-growth).

The delamination of the welded seam on the ascension pipe as observed following 1000 cycles did not worsen within the subsequent test cycles. The weakening at the ends of the welded seams also appeared to have stabilized by the 1000th cycle.

In this test a new procedure for a more rigid start and end weld pattern was tested. The conclusion of the minor separation and damage of the absorber sheet was that if too much laser energy is induced into the welding seam the rigidity of the aluminium absorber sheet can be reduced. An adjustment of this start and end pattern has shown no damage anymore.

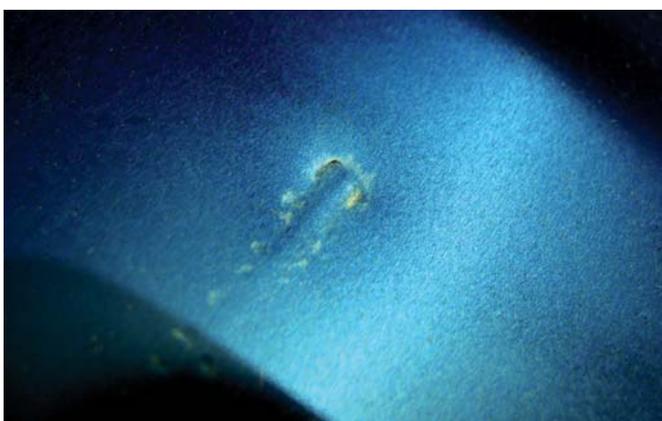
Figure 15: Mild damage of the absorber at the beginning of one of the welded seams.

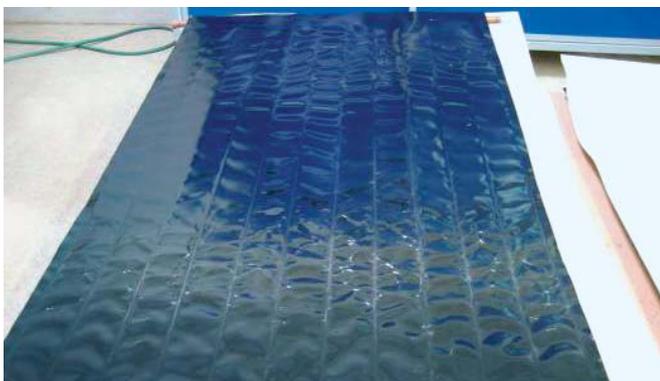
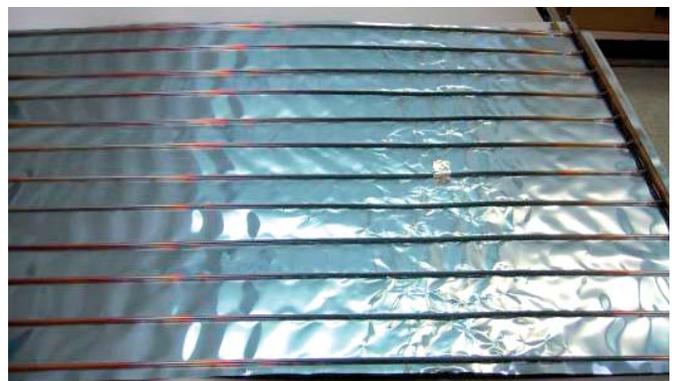
Results: The test was completed after 500 cycles and an assessment carried out. With the exception of a few ripples and deformations in the sheet metal, no changes were found. The weld joints between the tube array and the absorber plate did not show any defects at all. The

Images 1 and 2: Photo of the absorber after the shock test. Formation of ripples on the absorber plate.

With the exception of the ripples, no changes were found after the shock test. The result of the subsequent internal pressure test with 30 bars was also positive.

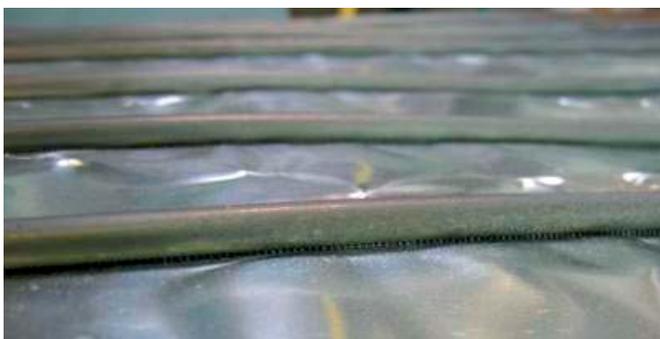
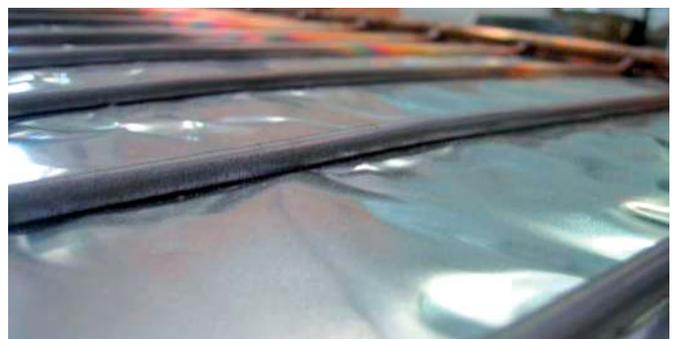
Images 3 and 4: Close-up photos showing the ripples on the absorber plate.

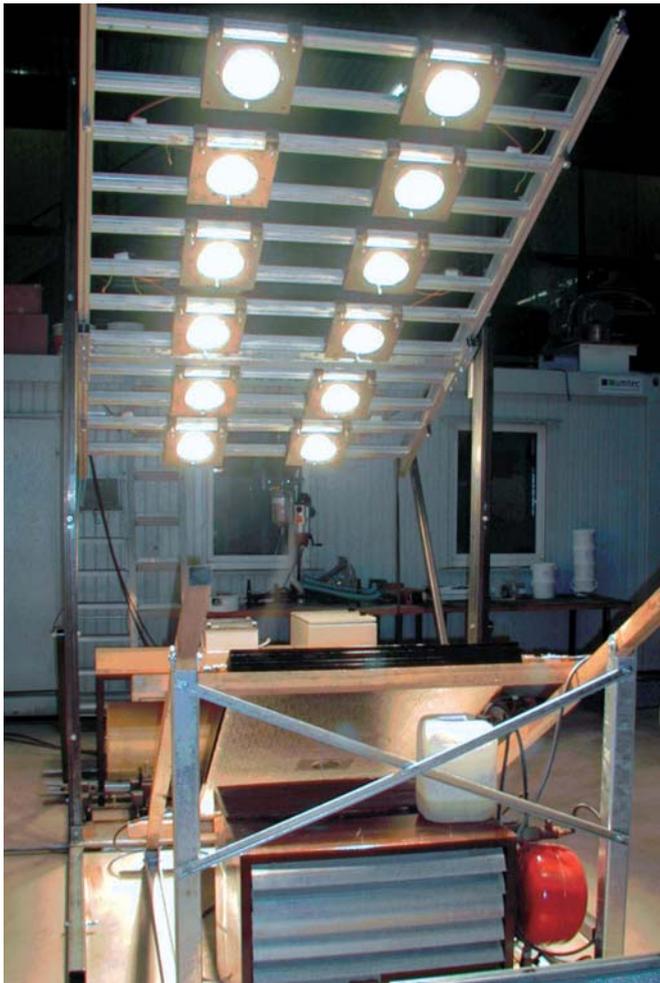
View of solar simulator

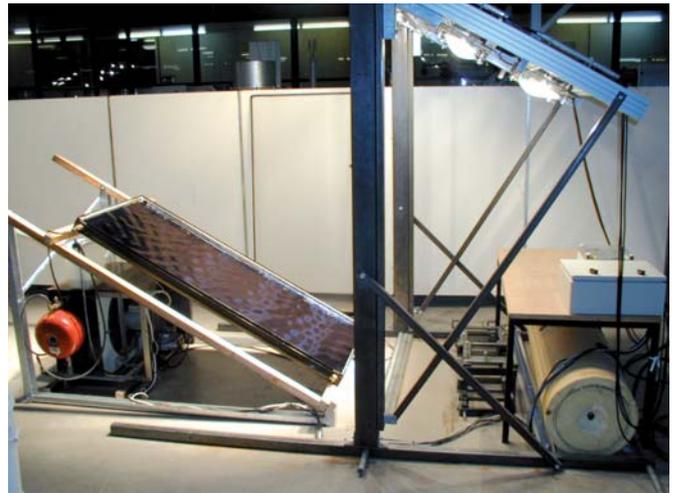
View of test setup

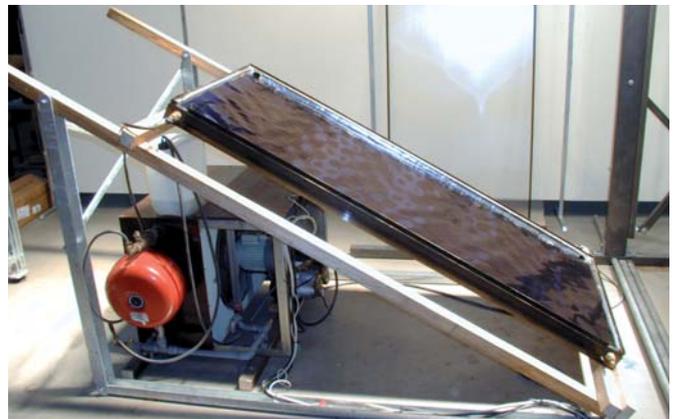
View of collector after exposure

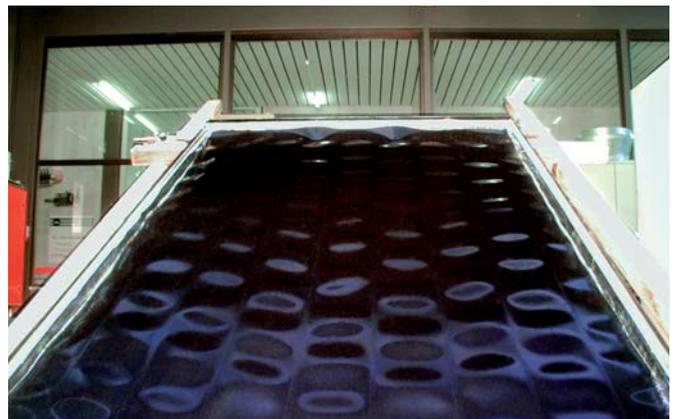
View of absorber after exposure

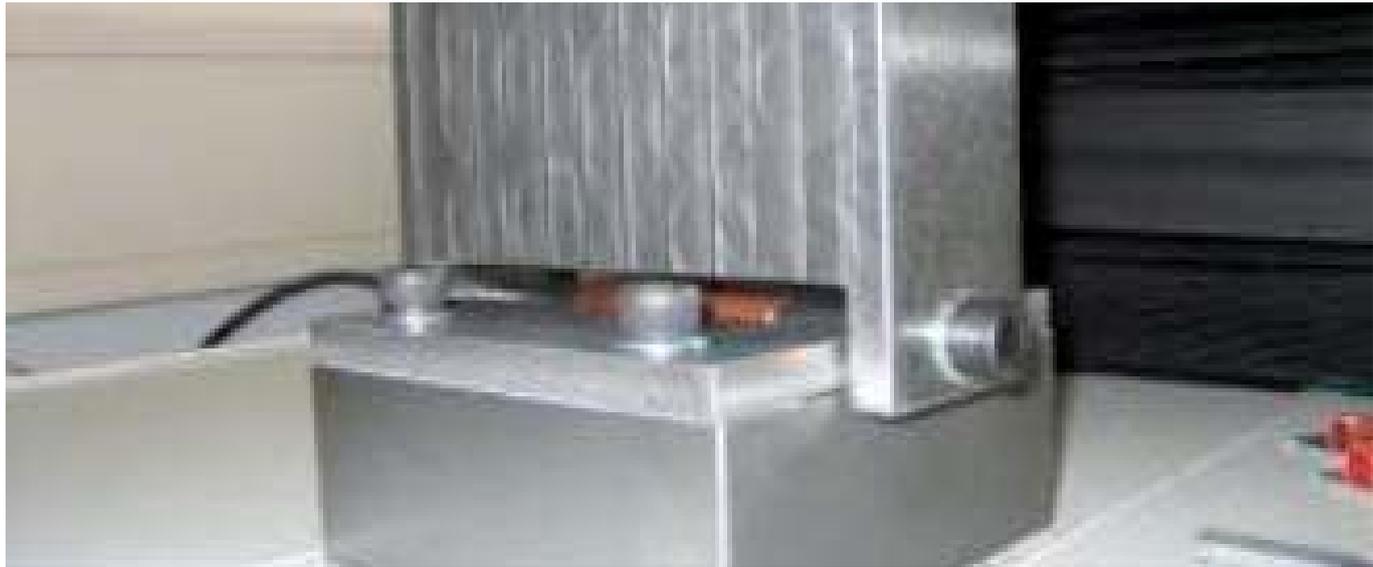
Photograph 1: Test setup

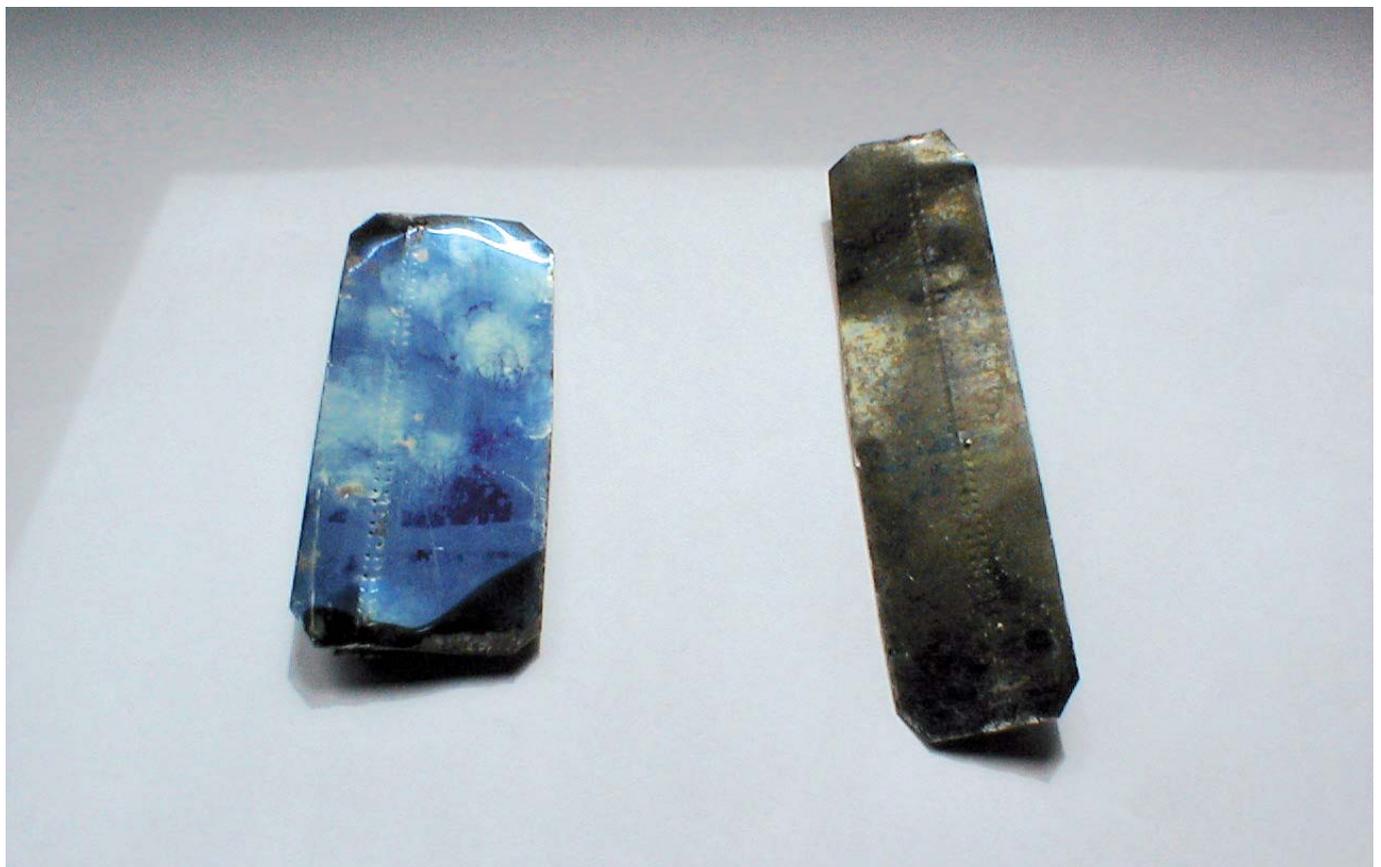
Front side

One has been put in the wet room DIN 50017 (40°C 100% humidity) for 240 hours : no damages, the other has been put in the salt mist test ISO 9227 (35°C 100%

humidity 5% NaCl) for 240 hours: few damages of the selective coat , no corrosion problems on the copper aluminium junction

Wet room

Salt mix test

It is obvious that such a harsh test will do damage to any selective coating. The important outcome of this test is that no galvanic corrosion occurred in between copper pipe and aluminium sheet.

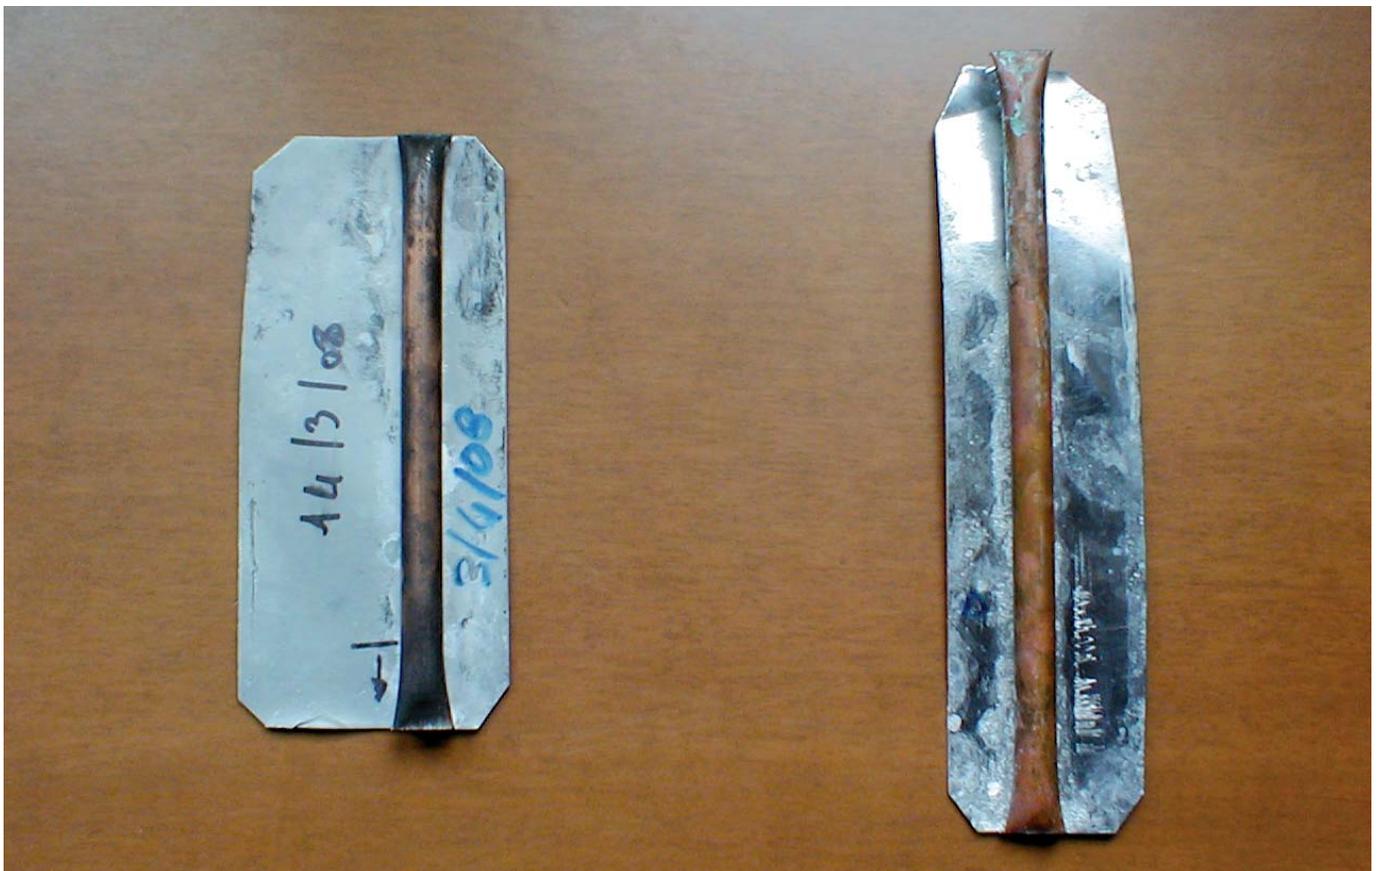
Reverse side

Wet room

Salt mix test

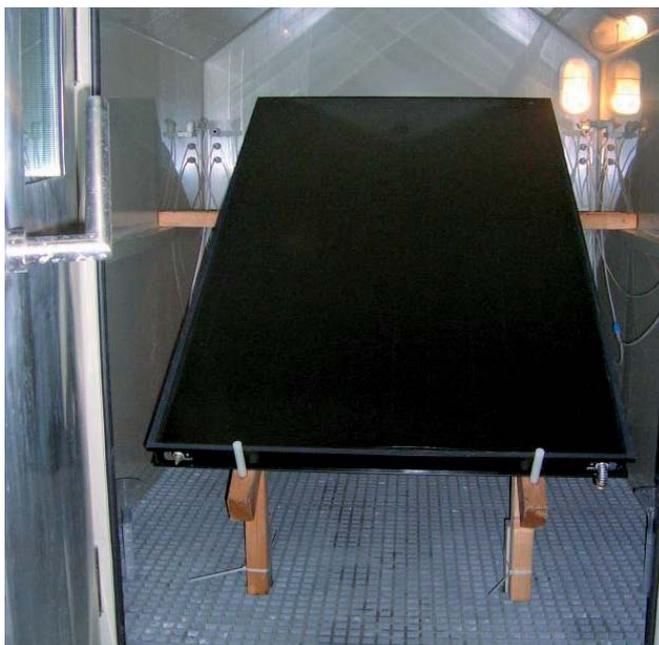
Picture 9: Set-up of collector in test chamber

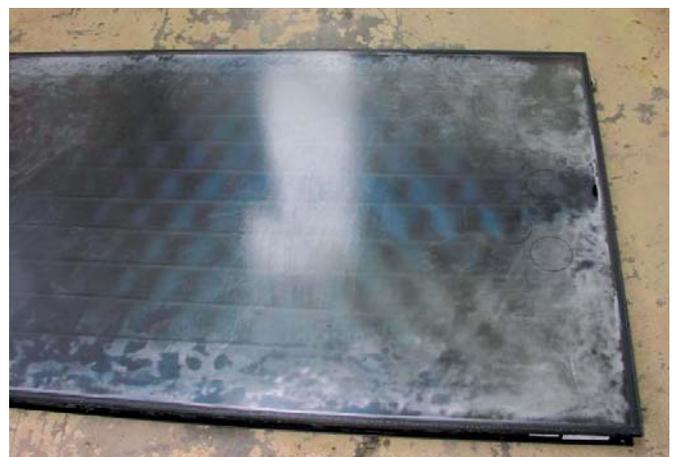
Picture 10: Humidity on the glass due to condensate inside the collector

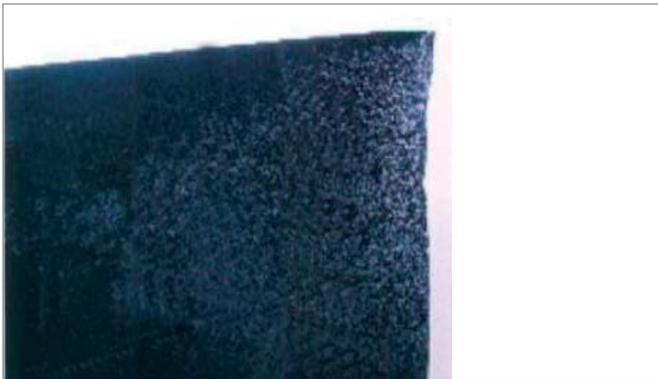
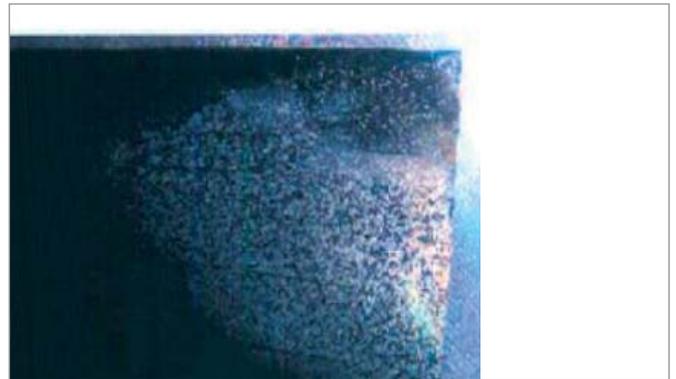
Bild 24: Verfärbung Absorberbeschichtung
Picture 24: Discolouration absorber coating

Bild 25: Verfärbung Absorberbeschichtung
Picture 25: Discolouration absorber coating

Bild 26: Verfärbung Absorberbeschichtung
Picture 26: Discolouration absorber coating

Bild 27: Verfärbung Absorberbeschichtung
Picture 27: Discolouration absorber coating

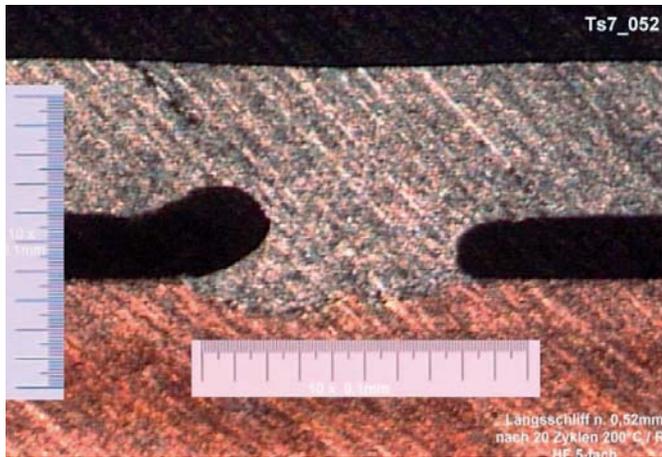
As documentation, Picture 4., to the same magnification as Picture 3., along the joint (copper tube) axis is shown. This picture is after the 168 hour test has been carried out, and it is clear to see that absolutely no corrosion of either the copper tube to the aluminium around the joint has taken place.

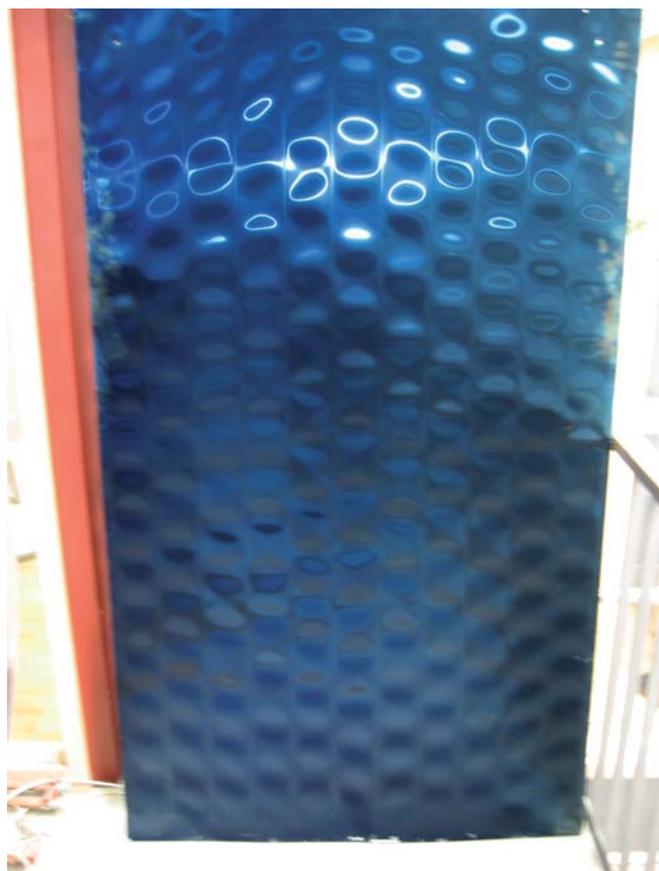
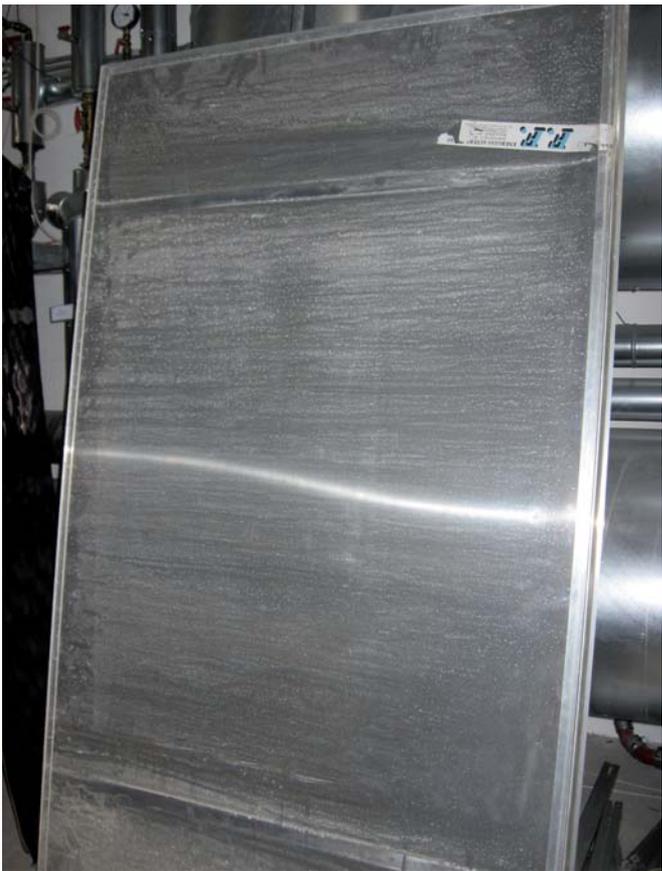
No signs of corrosion can be detected on the front or rear of the absorber, and the welding and contact points are also free of corrosion.

No loosening or separation of welding points is present, meaning that the copper-aluminium laser-welded joint is fully intact.

Sample photographs Solvis Cala / southwest coast of Portugal

The photographs intentionally show the dirt which has accumulated. See also the collector housing.
