STUDY REPORT

No. 184 (2007)

An Inspection of Solar Water Heater Installations

C D Kane, A R Pollard and J Zhao

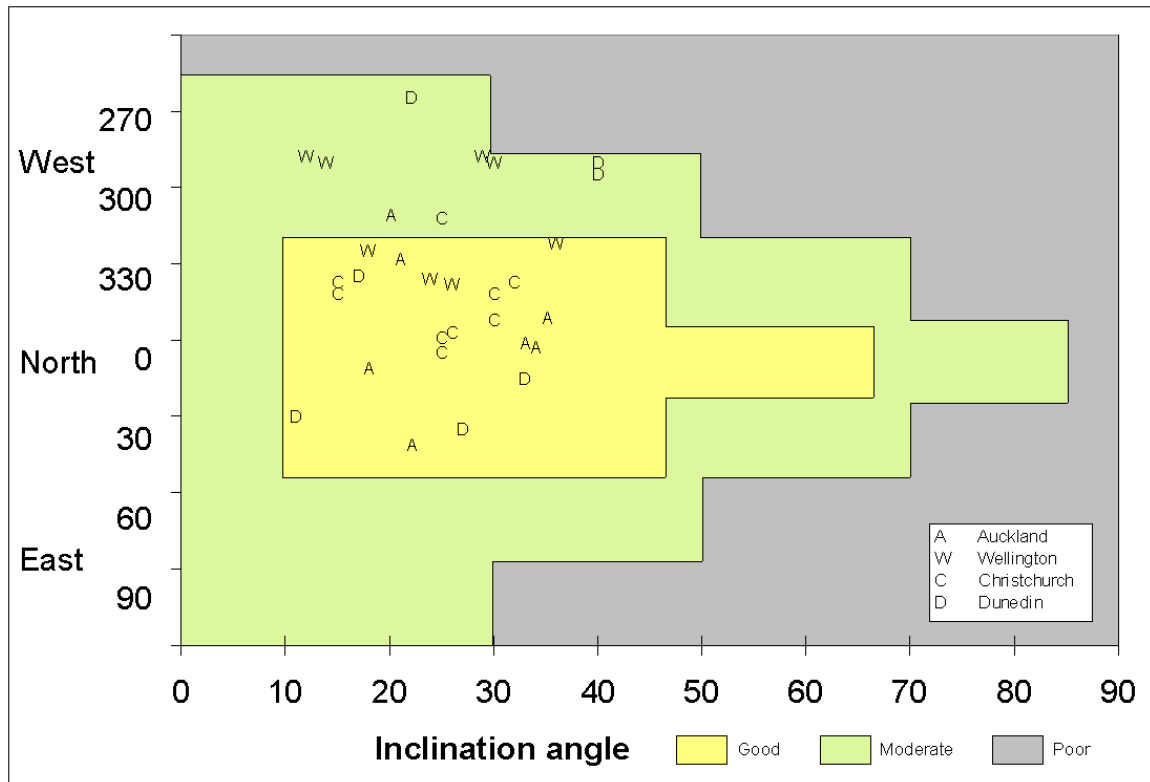
Figure 35. Orientation and inclination of solar collectors.

Many of the sample data points lie on the west side of north with an average direction 24° west of north (336°). The size and direction of this variation is similar to the magnetic correction (taken as 19° for Auckland, 22° for Wellington, 23° for Christchurch and 25° for Dunedin). A possible reason for this bias could be that many of the systems have been aligned using magnetic directions rather than grid (geographic) directions. For practical reasons, systems generally follow roofing directions so this may reflect that many of the houses have been aligned magnetically.

For the sample of 31 systems, 71% were installed within 45° of grid north (between NE and NW). The eight remaining systems were all located between NW and SW.

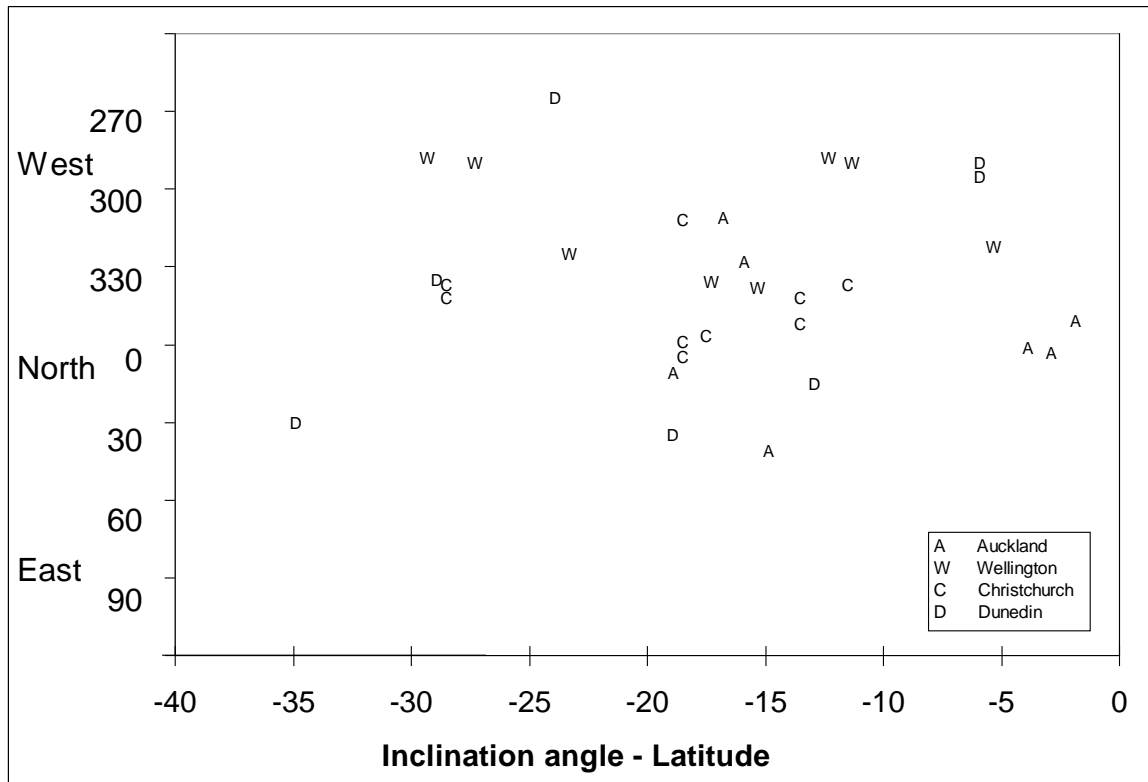
Figure 36. Excess of inclination angle over the site latitude (all numbers are negative).

Again for practical reasons, many of the systems were inclined at the same angle as the roofing material. The draft G12/AS2 requires that systems be installed within 20° of the sites latitude and 74% of the same were installed at an acceptable angle. Figure 36 provides a plot of excess of the inclination angle over the site latitude as well as the orientation of the panels. All of the systems inspected had inclination angles less than the latitude. The advantage of installing a system at an inclination angle greater than the latitude is that the winter performance of the solar water heater is improved. As SWH is very seasonal, improving the winter time performance will even out the supplementary heating requirements (and therefore running costs) for the occupants.

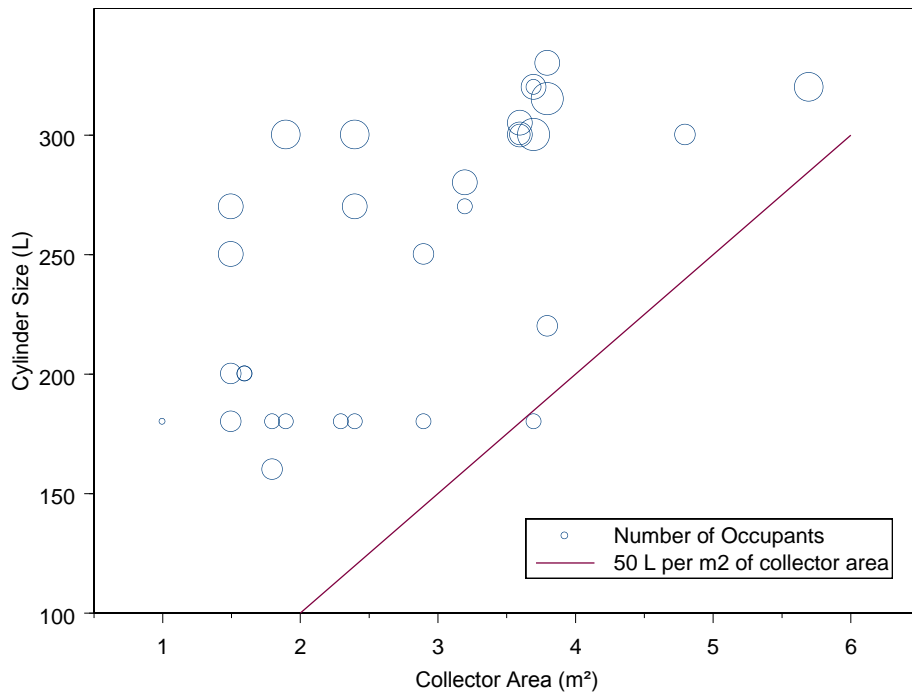
Figure 38. Cylinder size by collector area.

Only one case (3%) was below the line with the average ratio of cylinder volume to collector area being 99 Lm^{-2} . Collector efficiencies vary by technology and it may be appropriate to assign different cylinder volumes depending on the technology used. Figure 39 gives the cylinder size and collector area shown in Figure 38, but this time displays a code for the technology used.
